Town of Dover

Road-Stream Crossing Management Plan

Produced by
The Housatonic Valley Association
2019

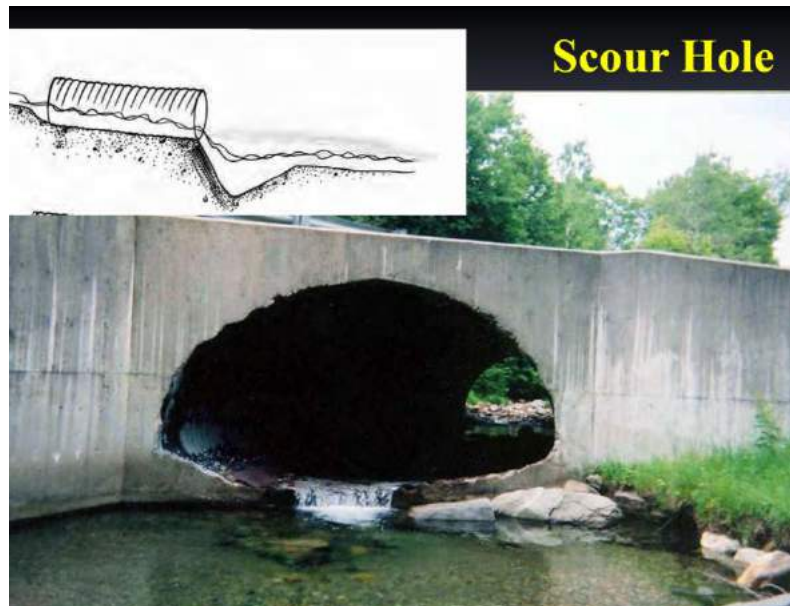
Scour hole downstream of an undersized culvert. Photo/diagram credit: UMASS River and Stream Continuity Program

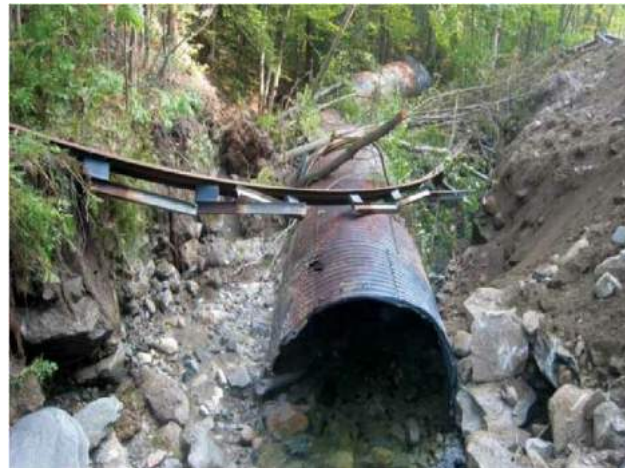
Road failure at a 3-m culvert placed within a 6-m bankfull width stream, GMNF

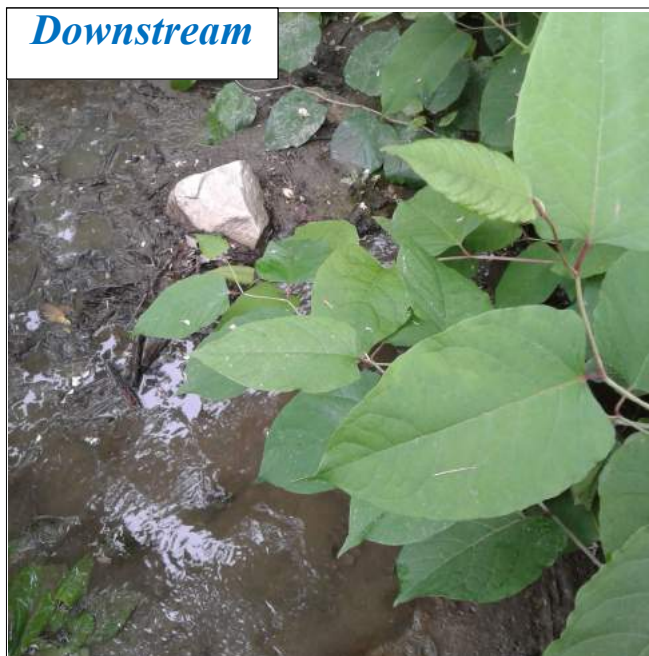
Downstream

Crossing Comments: Poor Condition. Spoke to resident who believes guardrail should be added and said many accidents occur at this turn and the cars flip into the stream. Usually

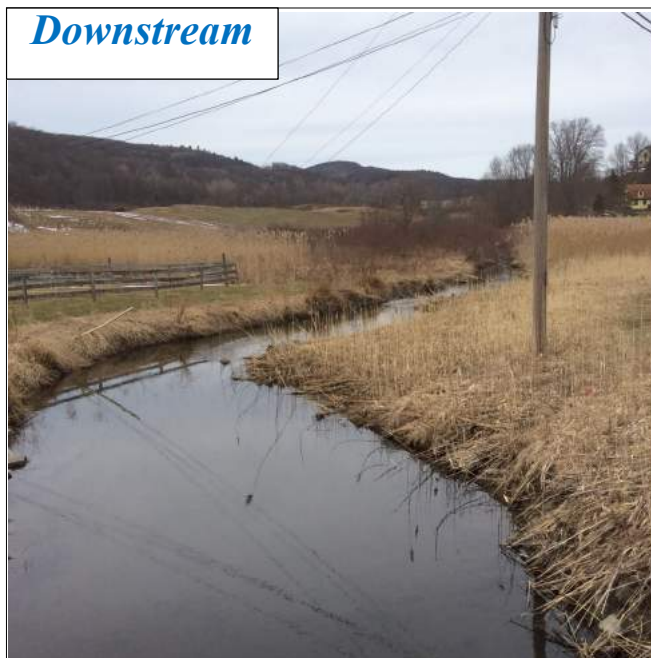
Downstream

Crossing Comments: Limited access to property, spoke to adjacent landowners who noted beaver damage, bridge did flood in 1955
