Town of Dover

Road-Stream Crossing Management Plan

Produced by
The Housatonic Valley Association
2019

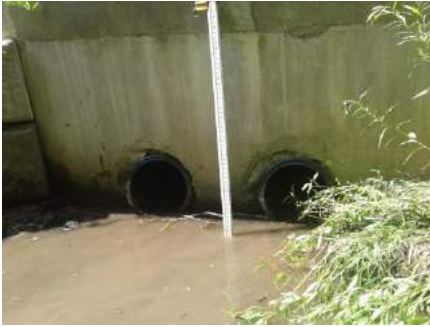
Undersized Crossings

A crossing that is too small relative to its bankfull width can lead to faster flows, which in turn can cause erosion at the inlet and outlet (see Outlet Drops and Scour & Erosion below). Undersized crossings are often accompanied by outlet drops and/or scour pools that result from excess flows.

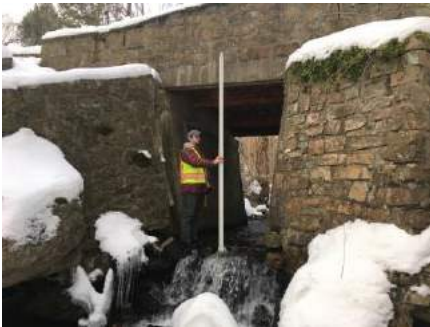
Outlet Drops/Perched Culverts

Crossings that are undersized may have large drops at the outlet, which are called outlet drops or perched culverts. Such drops can be caused by erosion/scouring of the downstream stream bed

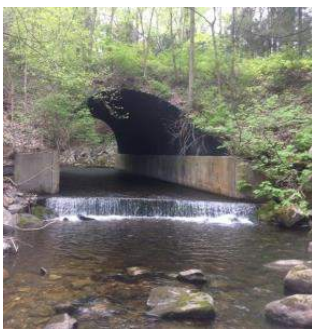
Shallow Crossings

Crossings that are undersized or improperly aligned can lead to high flows and erosion that can lead to the water inside the structure being too shallow. Inadequate depths can pose a barrier to fish passage. They also usually lack a substrate that matches stream bed. These crossings can be impassable or even dry for long periods of time.

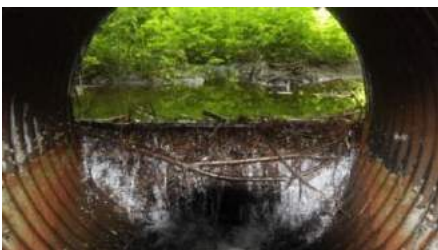
Clogged Crossings

Undersized crossings are more likely to clog with debris. Beaver activity can exacerbate this problem. If not maintained, a clogged crossing will become impassable to fish for as long as the clog is present. Clogged inlets can also cause upstream ponding and/or flooding, and the formation of inlet drops.

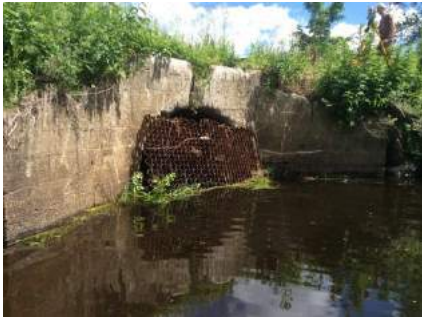
Ponding is the backup of water upstream of an undersized crossing. Typically, the ponded water upstream becomes stagnant, leading to increased temperatures, lower oxygen levels, and poor fish habitat. Ponding can lead to stream bank and road erosion, damage of surrounding property, and creation of wetland ecosystems. It may occur seasonally due to high waters/flooding, or year-round due to induced effects such as clogging.

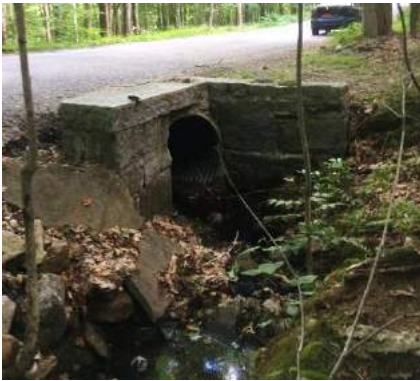
Misaligned Crossings

A crossing whose inlet is skewed in relation to the stream is considered misaligned. Misaligned crossings can result from improper installation (e.g. installing a pipe perpendicular to the road, even though the stream approaches at an angle). Misaligned crossings have a higher probability of clogging, scouring or eroding, and producing ponding.

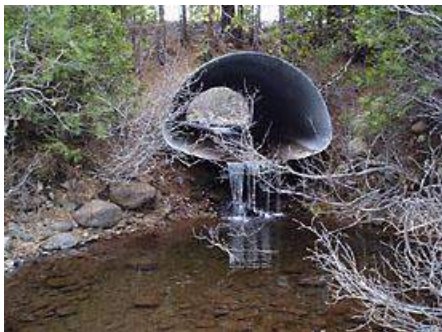
Scour and Erosion

Scour and erosion goes hand-and-hand with high flow and ponding, and is a consequence of all crossing insufficiencies besides shallow crossings. Scour pools often form at the downstream end of perched crossings, leading to the undercutting of the crossings, or in a worse case, the road. Eroded stream banks occur both upstream and downstream of the crossing. Lastly, scouring of natural substrate within the crossing degrades passage and natural habitat for aquatic and terrestrial life.

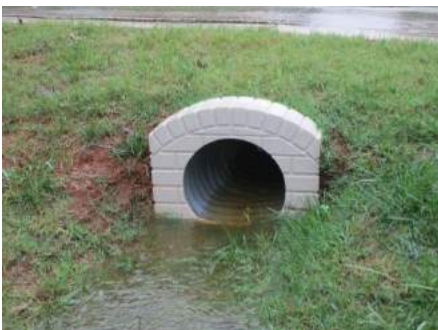
Lack of Substrate

It is recommended that metal, smooth, and unnatural materials, such as concrete, not be used when constructing a culvert. Many aquatic organisms maneuver through the stream by gripping or latching onto rocks. When implementing a substrate through a culvert one must match that of the natural stream. By doing so the natural conditions are maintained, stream continuity remains uninterrupted, and scour is avoided.

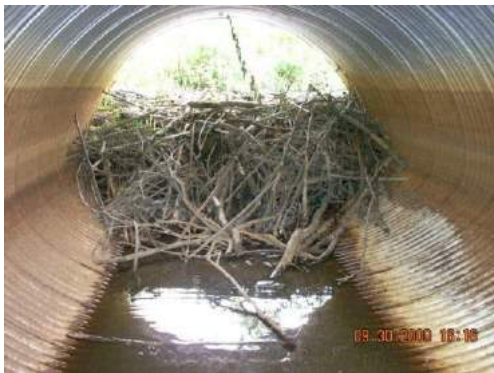
Beaver Activity

Undersized culverts, which constrict flow, are almost irresistible to beavers. Source: www.martinezbeavers.org/wordpress

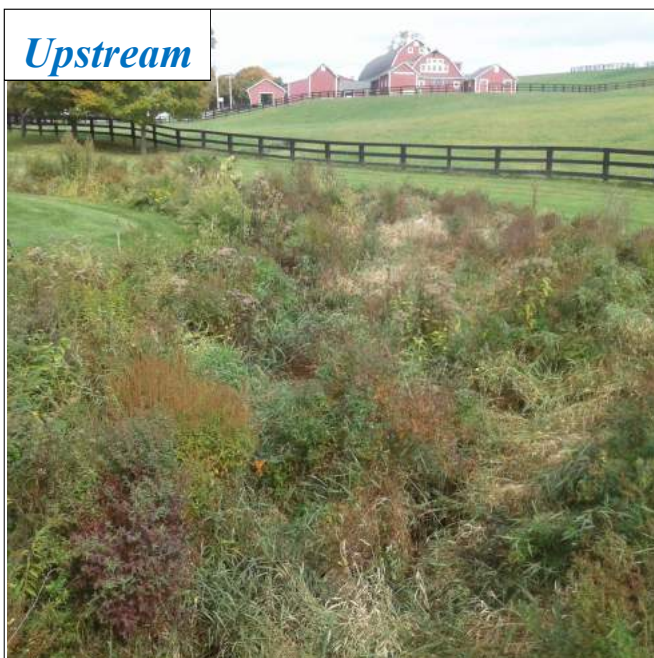
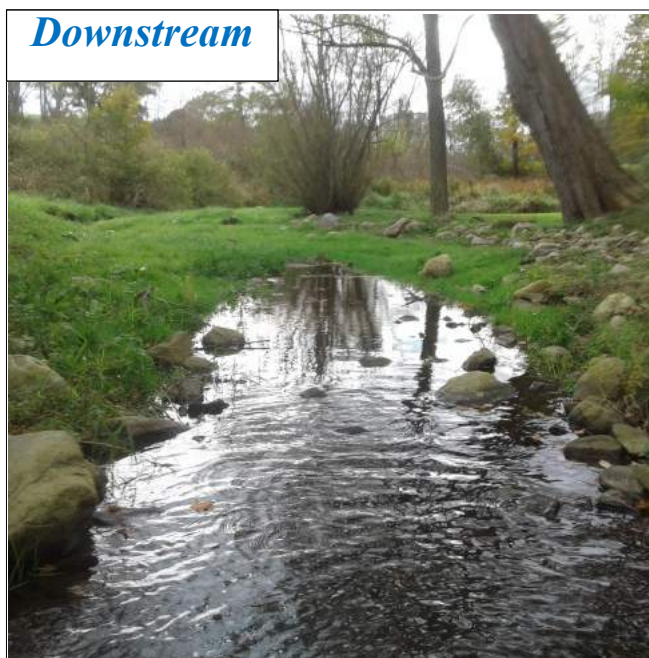
Crossing Comments: Starts as round culvert and changes to bridge half way with free fall.

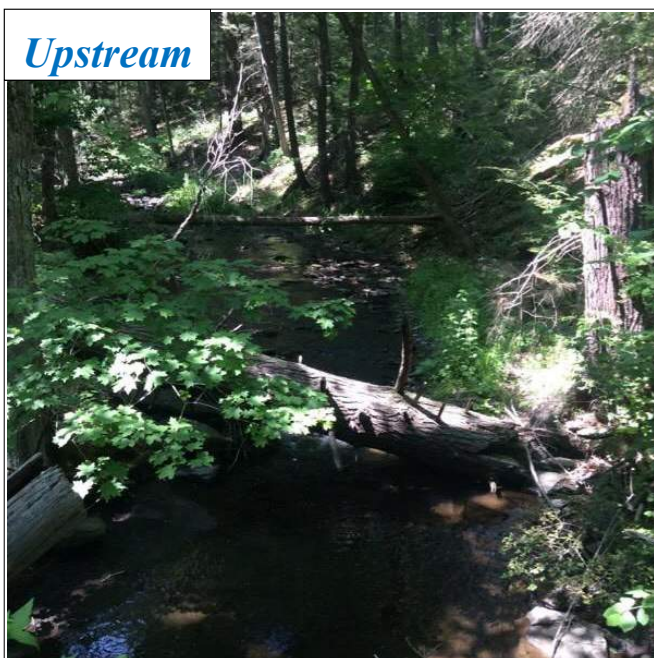
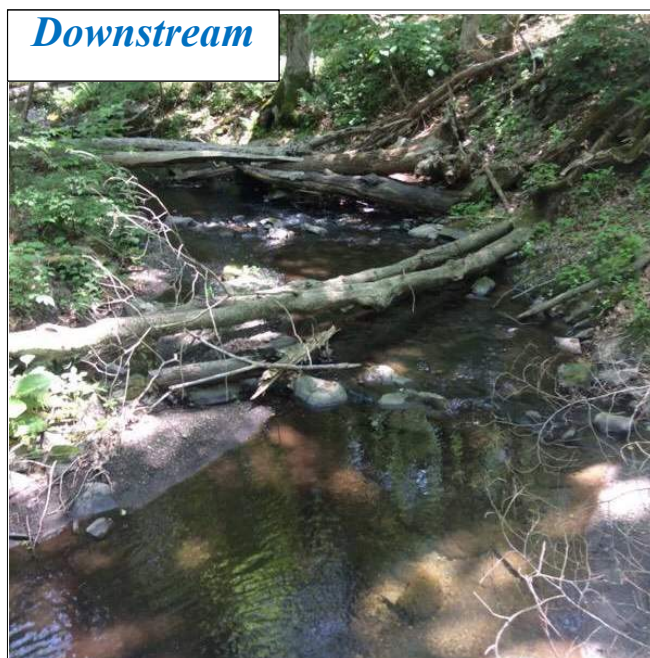
Condition: Poor

Crossing Comments: Culvert is rotting

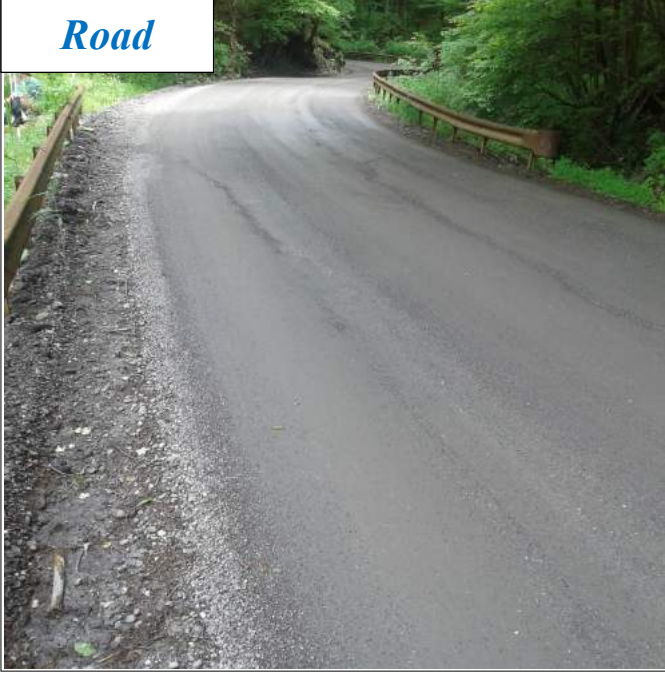
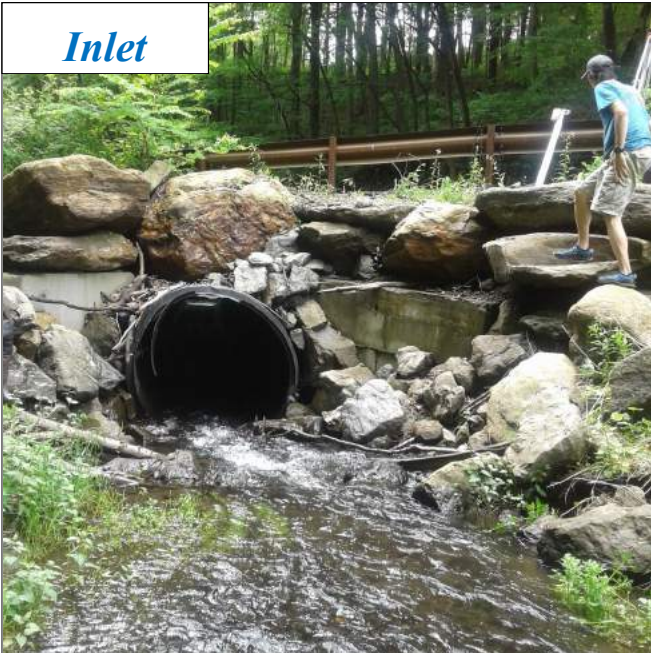
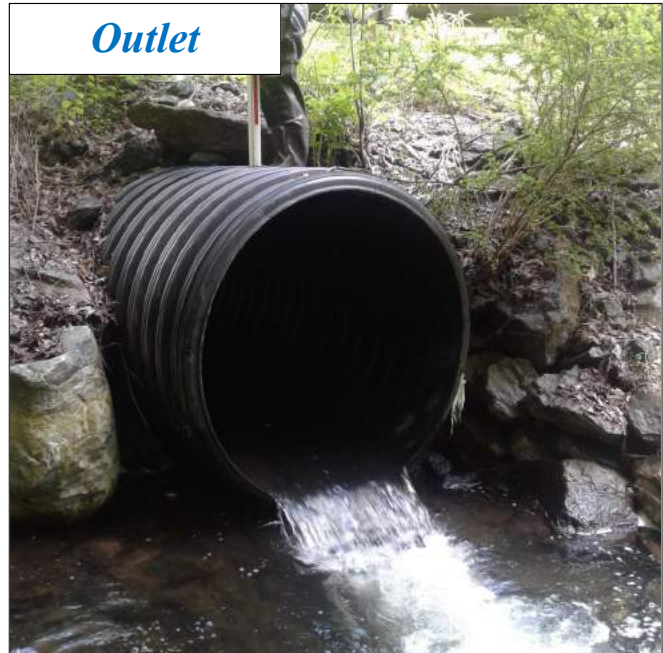
Outlet Shape: Round Culvert
 Outlet Drop/Grade: Free Fall
 Drop to Stream Surface/Bottom: 1.3/ 2.0
 Dimensions:

Town's highest priority for replacement (public safety), has flooded in the past, with water over the road in 2007, in disrepair, debris jams, town water line on west side

Condition: Poor

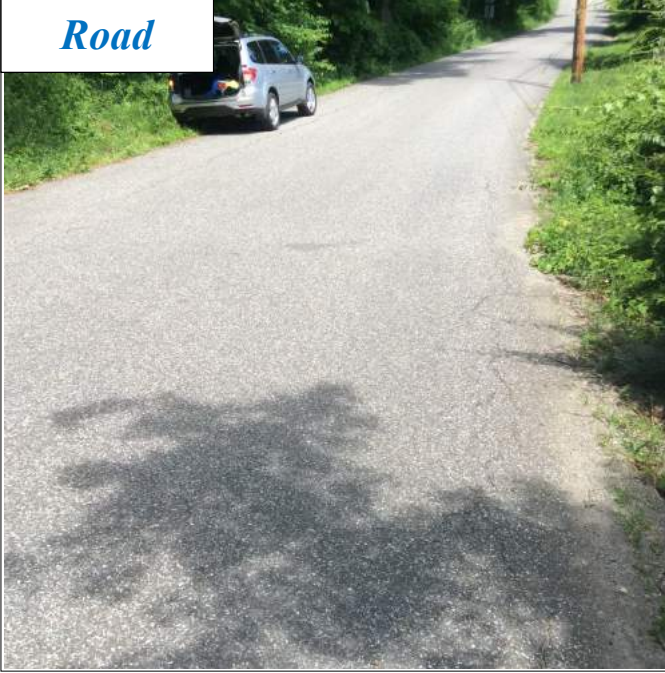
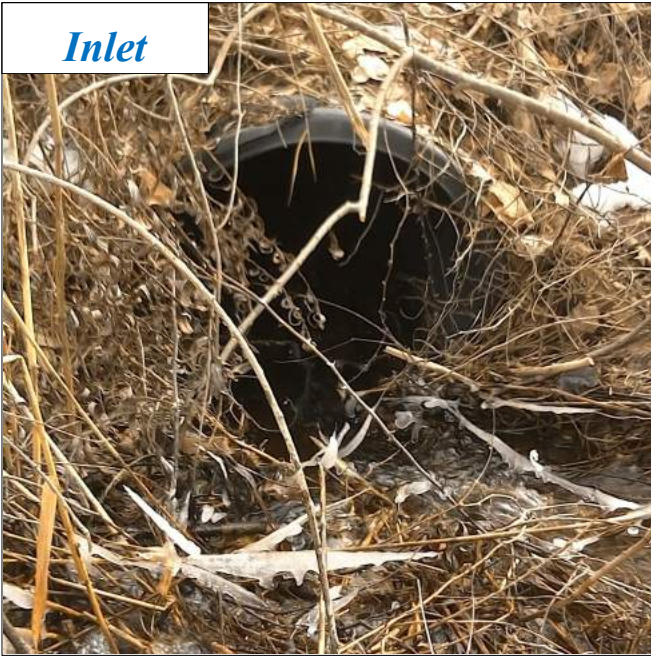
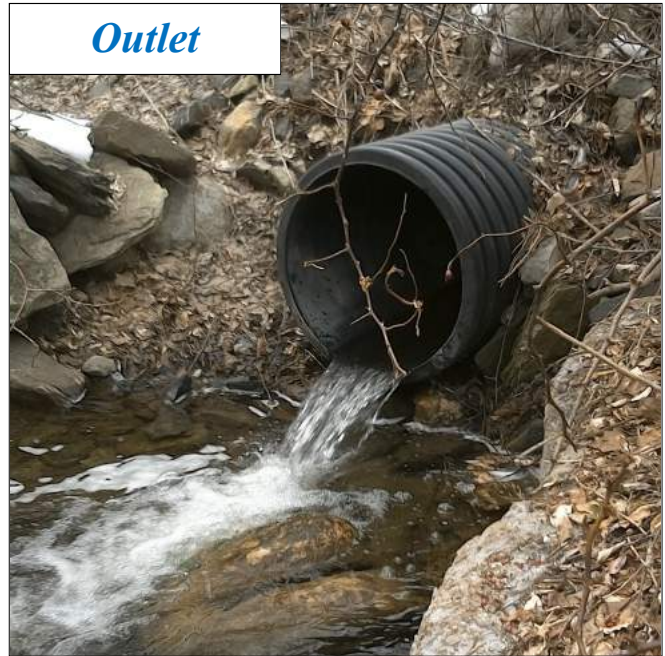
Crossing Comments: Cannot get to outlet due to barbed wire

Structure Comments: could not fully get to outlet to record outlet drop (free fall)-measurement is

Barrier Evaluation: Severe barrier

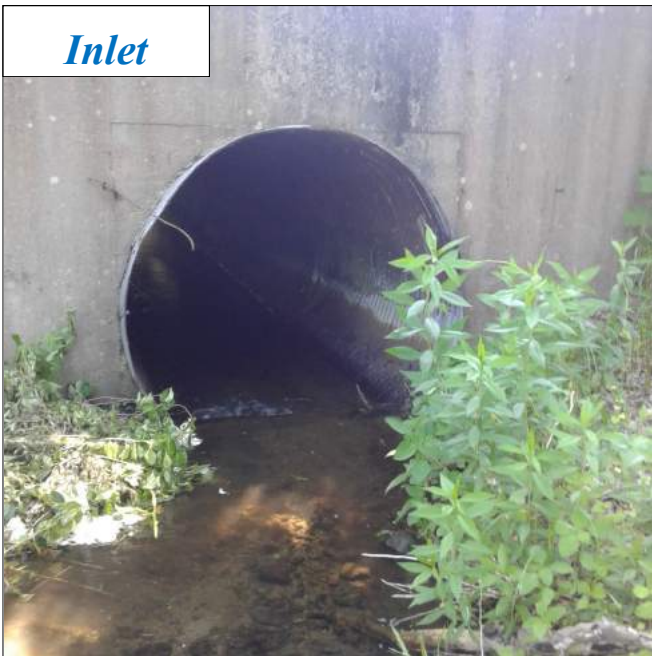
Physical Barrier(s)/Severity: Debris/Sediment/
 Rock (Moderate)
 Slope: No data
 Structure Comments: No data

Inlet Shape/Type: Round Culvert
 Inlet Drop/Grade: At Stream Grade
 Dimensions:

Width: 5.8, Height: 6.1
 Substrate/Water Width: 3.9
 Water Depth: 0.9
 Abutment Height: No data

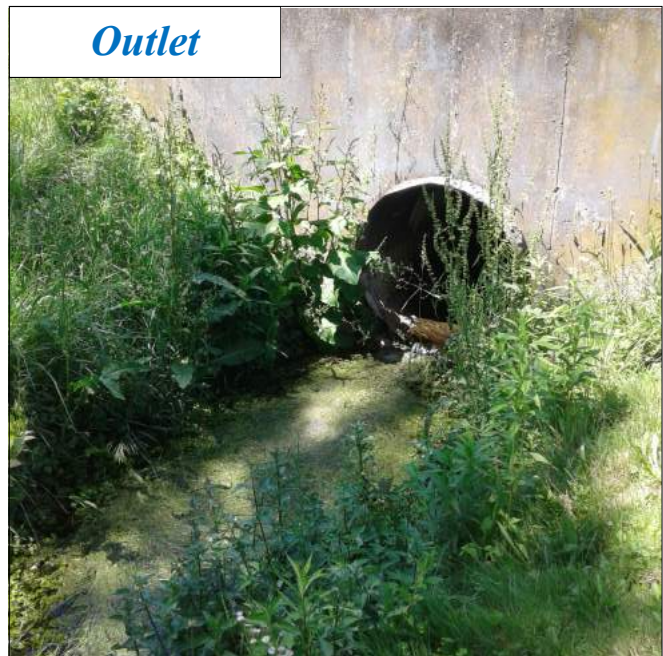
Outlet Shape: Round Culvert
 Outlet Drop/Grade: Free Fall
 Drop to Stream Surface/Bottom: 0.3/ 0.7
 Dimensions:

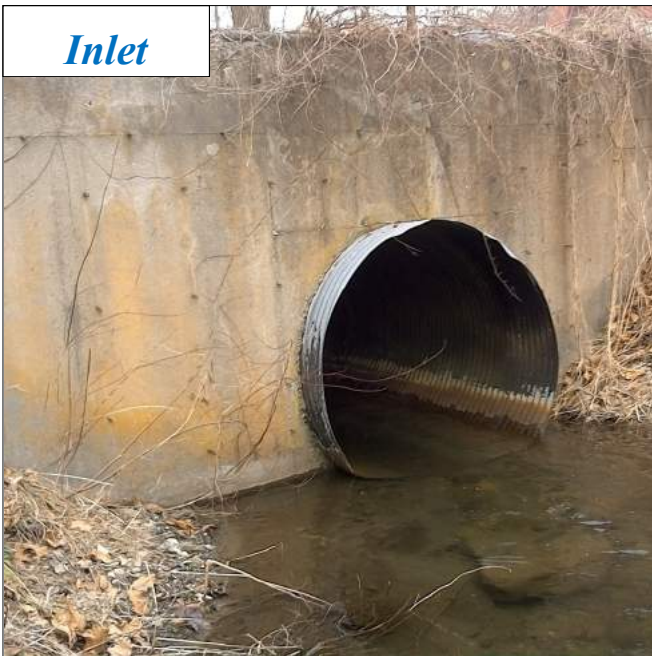
Physical Barrier(s)/Severity: Debris/Sediment/
 Rock (Minor)
 Slope: 2.9%
 Structure Comments: No data

Inlet Shape/Type: Round Culvert
 Inlet Drop/Grade: Perched
 Dimensions:
 Width: 5.8, Height: 6.2
 Substrate/Water Width: 3.0
 Water Depth: 0.6
 Abutment Height: No data

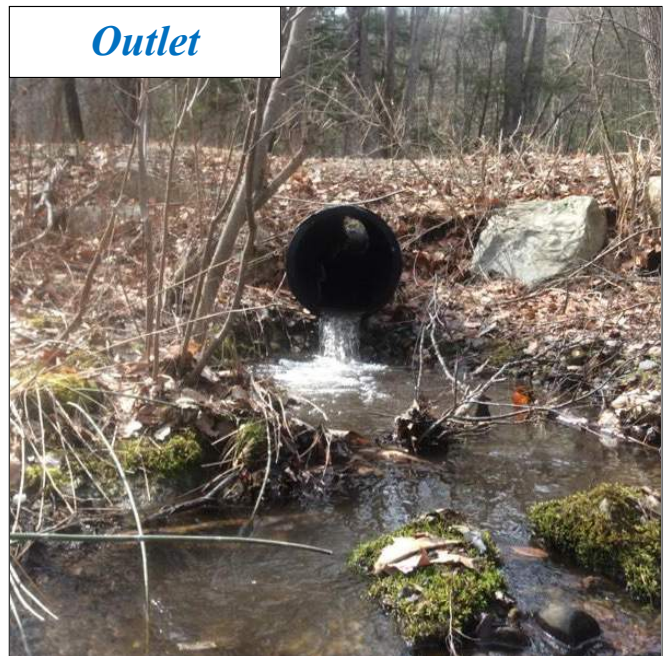
Outlet Shape: Round Culvert
 Outlet Drop/Grade: Free Fall
 Drop to Stream Surface/Bottom: 0.6/ 1.1
 Dimensions:

Barrier Evaluation: Moderate barrier

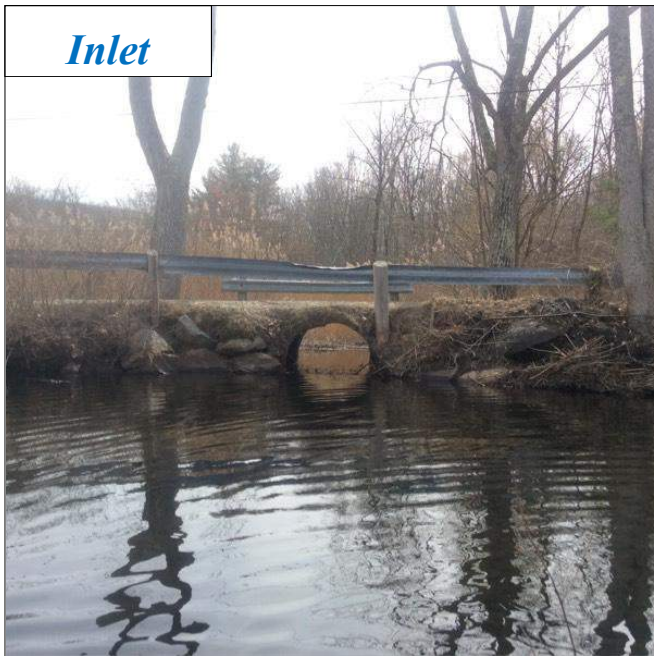
Inlet

Physical Barrier(s)/Severity: Debris/Sediment/
 Rock (Moderate)
 Slope: 6.4%
 Structure Comments: Vegetation and debris (due

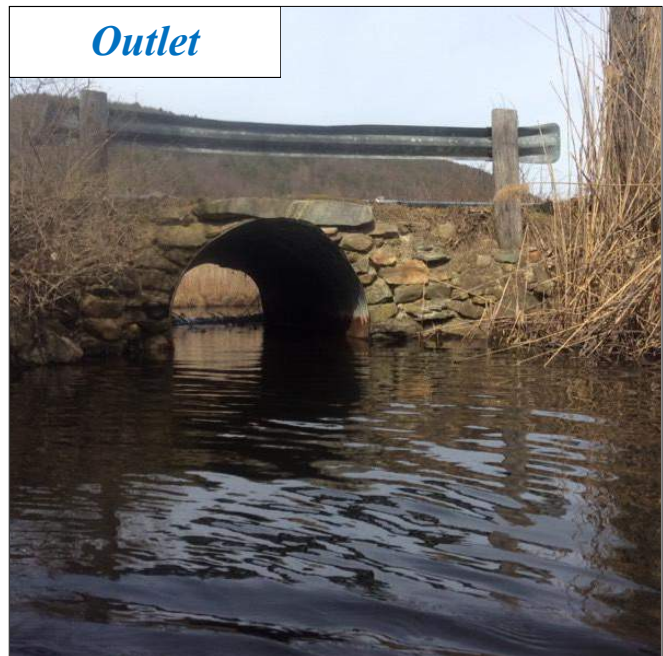
Outlet

Barrier Evaluation: Severe barrier

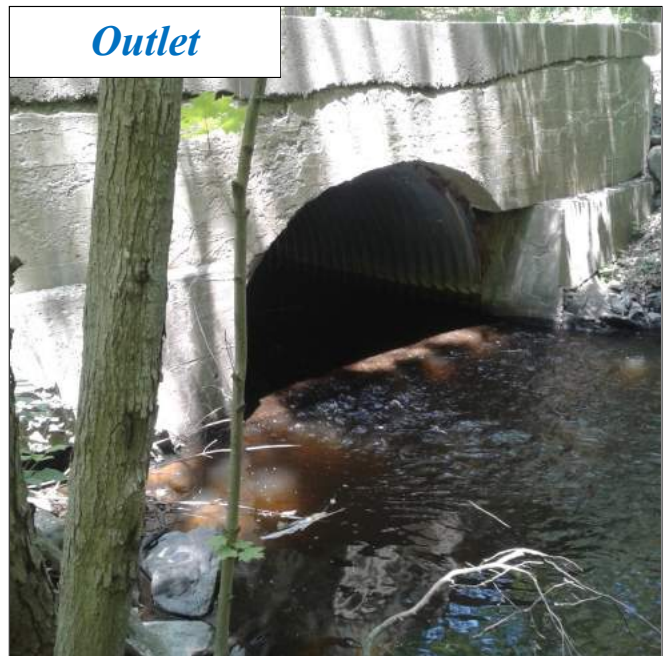
Outlet Shape: Pipe Arch/Elliptical Culvert

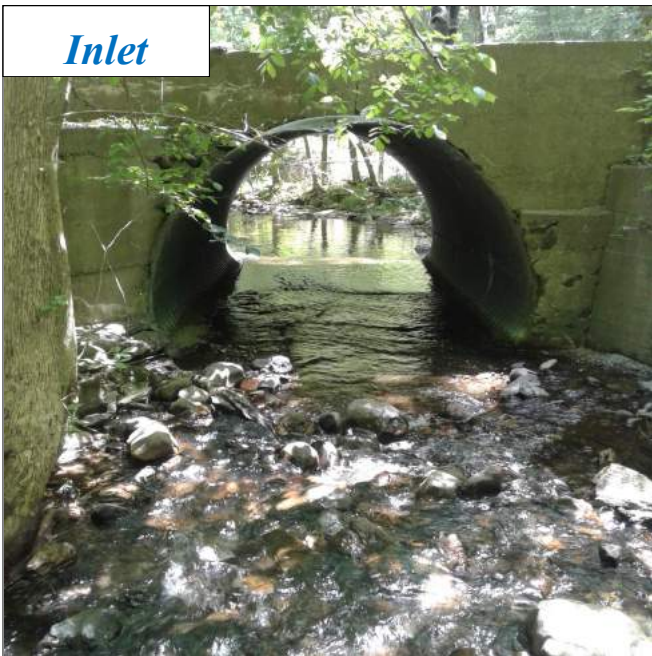
Inlet Shape/Type: Open Bottom Arch Bridge/Culvert

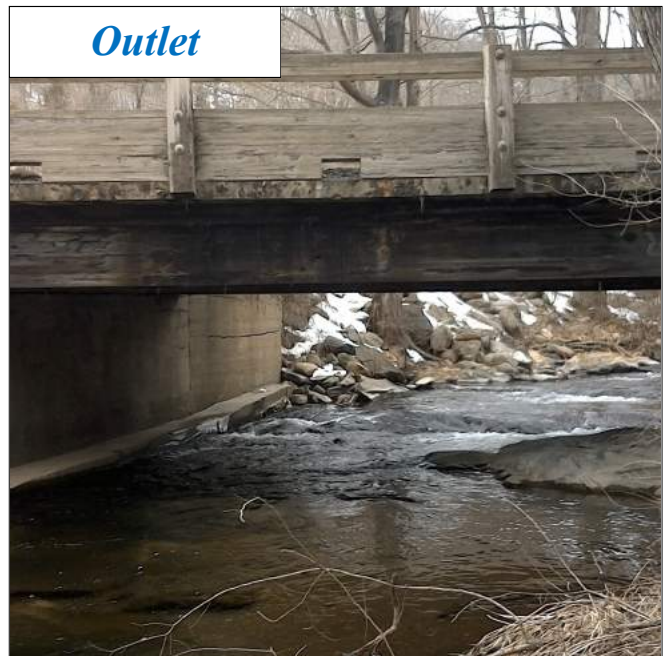
Structure Comments: Outlet too deep to take adequate picture of outlet

Outlet Shape: Bridge with Side Slopes

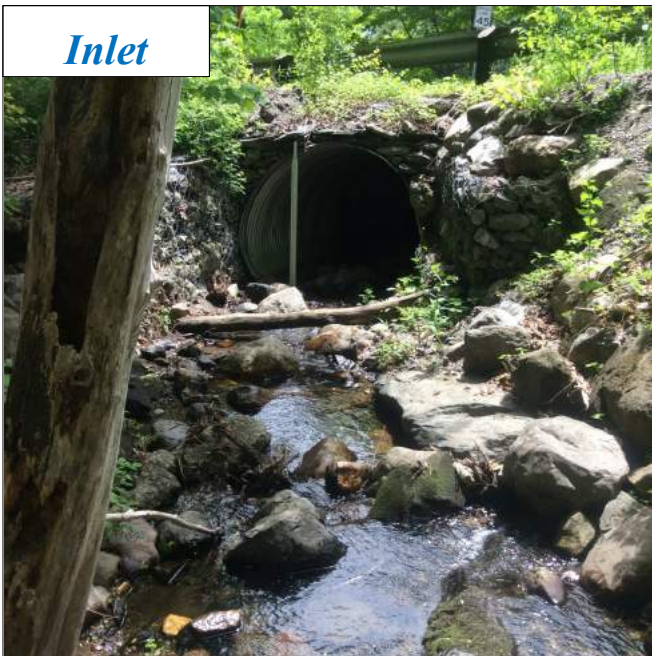
INLET

Structure Comments: Most of downstream left contains gabions

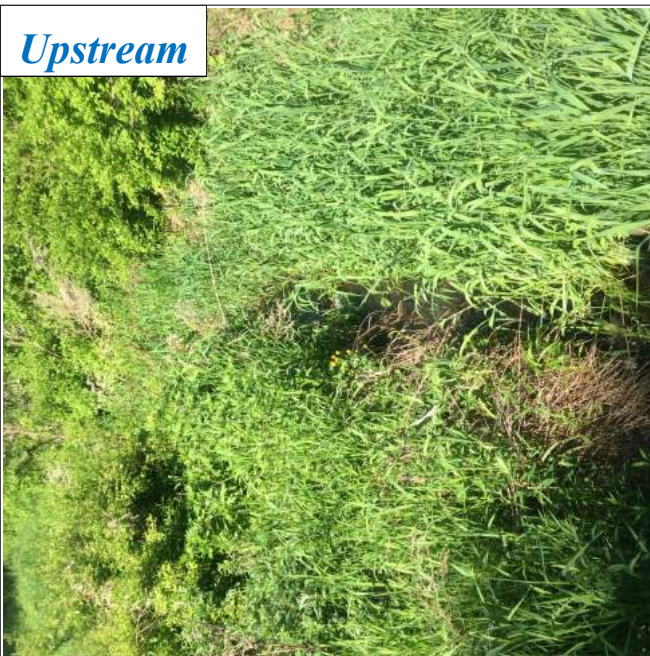
Crossing Comments: Upstream channel is densely populated with vegetation

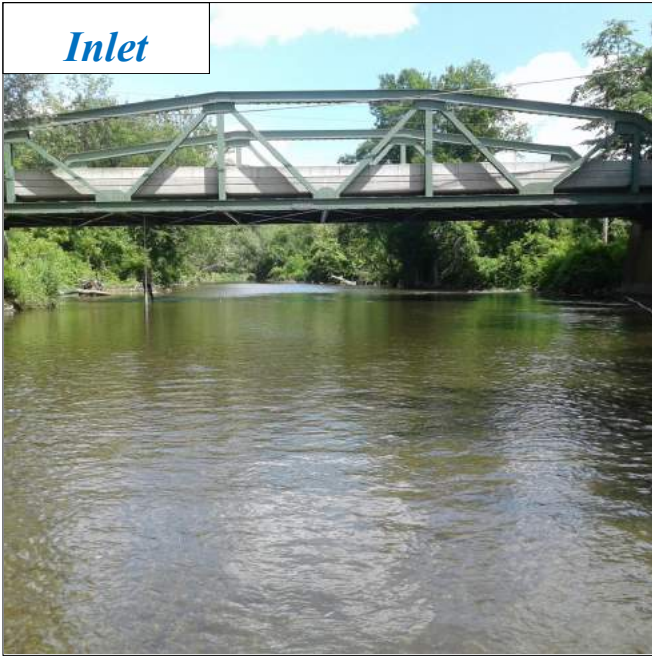
**INLET**

Structure Comments: Ridge near vertical abutment water is deeper on both sides

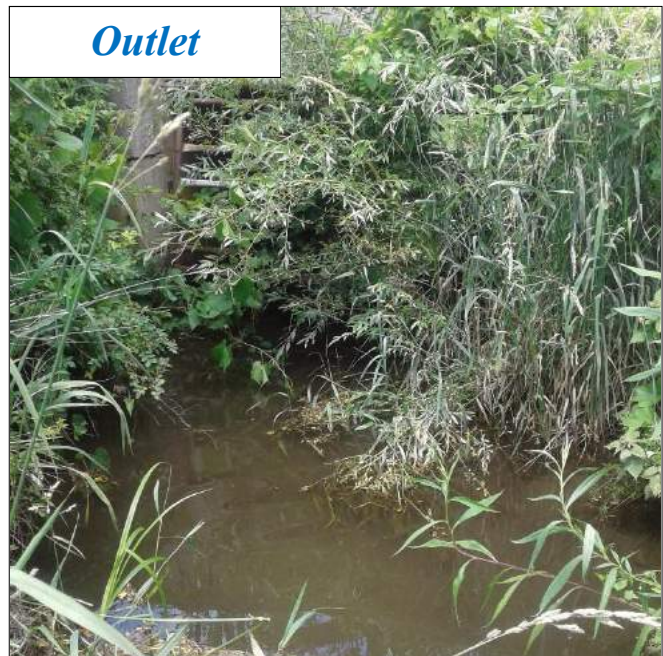
**OUTLET**

Crossing Comments: Additional photo shows the fencing at the outlet

Structure Comments: Fencing at outlet

Needs to be replaced

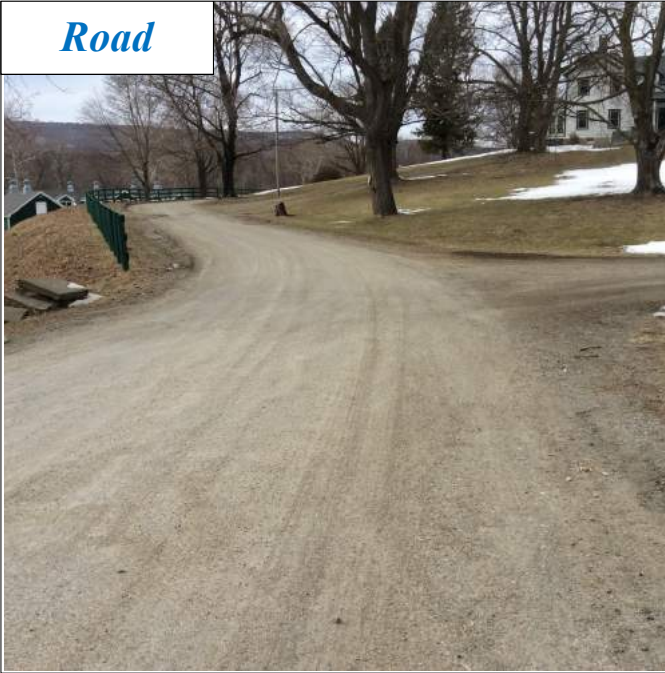
**ROAD**

Physical Barrier(s)/Severity: Debris/Sediment/
 Rock (Moderate)
 Slope: 5.7%
 Structure Comments: No data

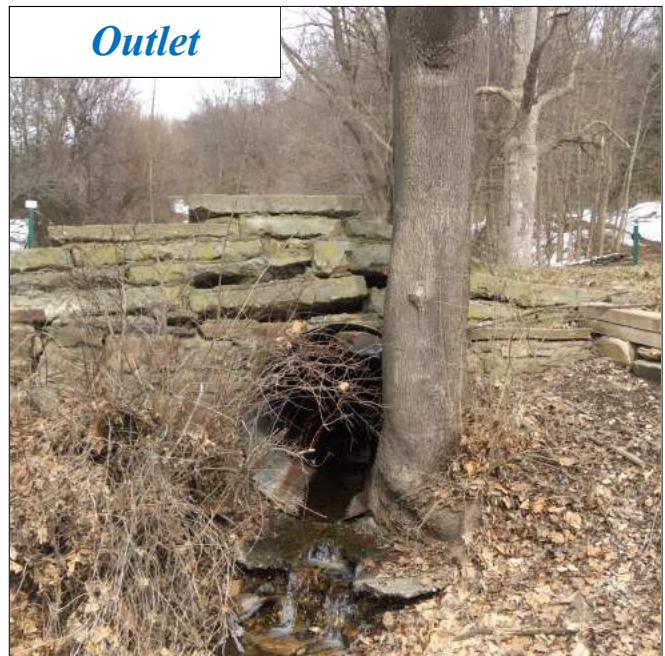
**OUTLET**

Outlet Shape: Round Culvert
 Outlet Drop/Grade: Free Fall Onto Cascade
 Drop to Stream Surface/Bottom: 2.7/ 2.7
 Dimensions:

Barrier Evaluation: Significant barrier

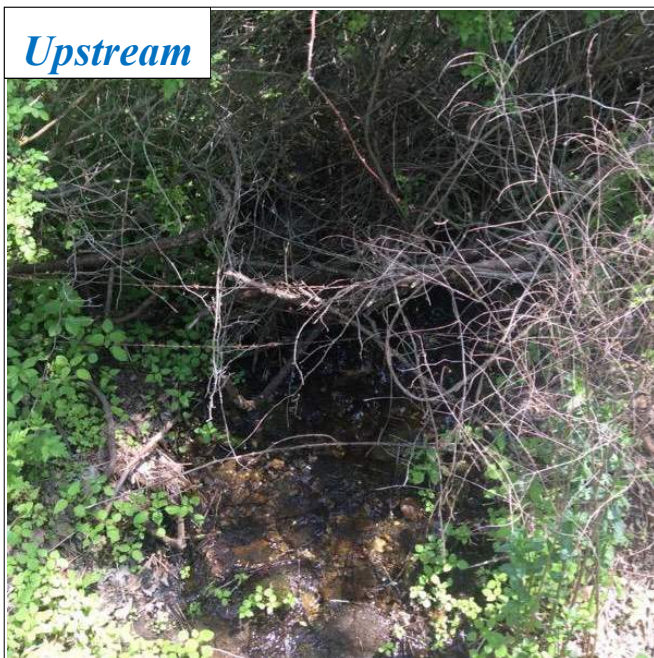
Crossing Comments: Barbed wire prevents animals from entering stream

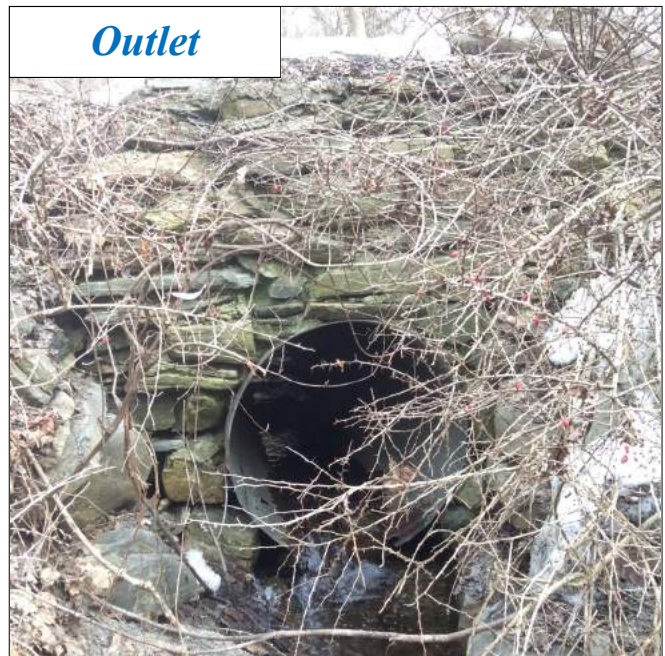
Outlet Shape: Round Culvert
 Outlet Drop/Grade: Free Fall
 Drop to Stream Surface/Bottom: 0.7/ 1.0
 Dimensions:
 Width: 3.0, Height: 3.0
 Substrate/Water Width: 1.1
 Water Depth: 0.3

Barrier Evaluation: Minor barrier

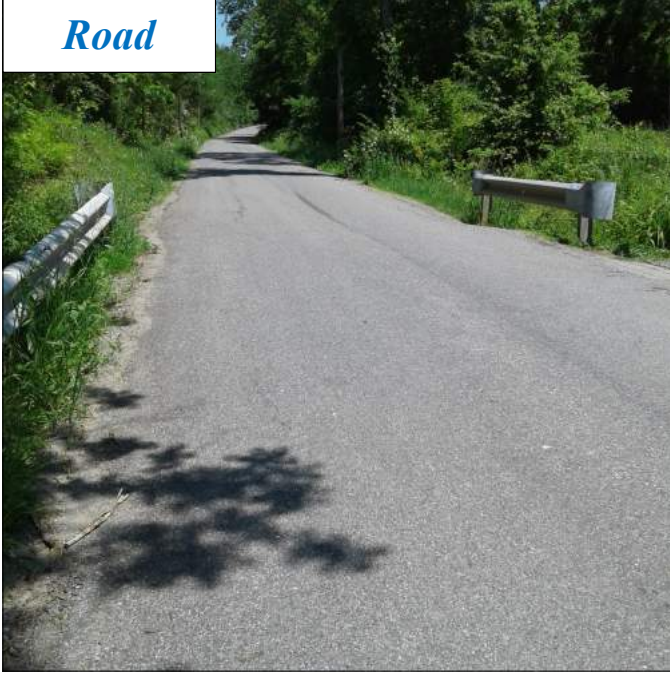
Road

Physical Barrier(s)/Severity: Debris/Sediment/
 Rock (Moderate)
 Slope: 0.7%
 Structure Comments: No data

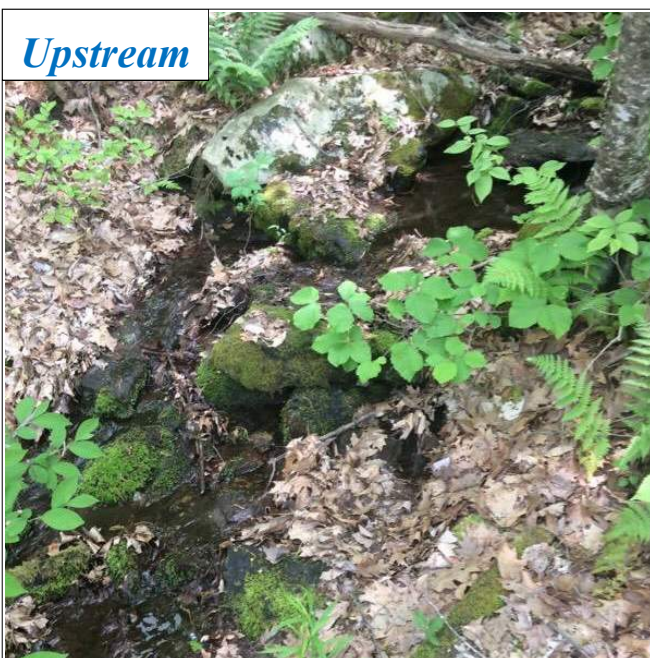
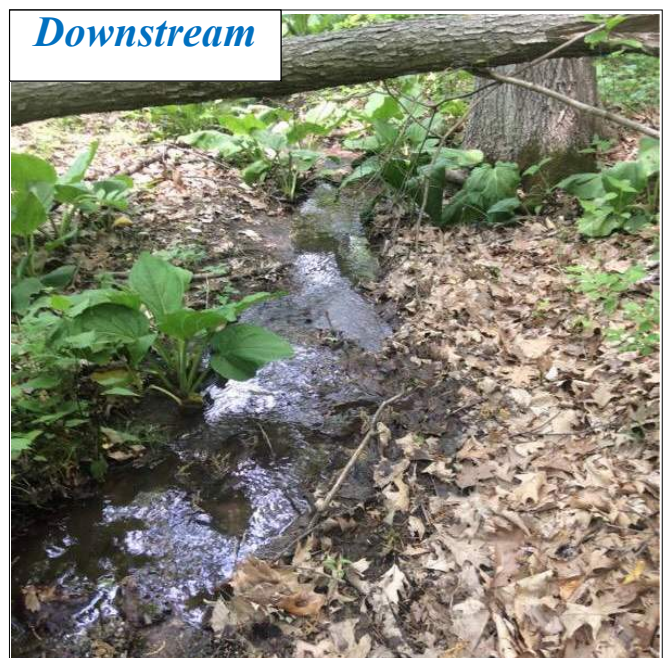
Crossing Comments: Culvert is rotting

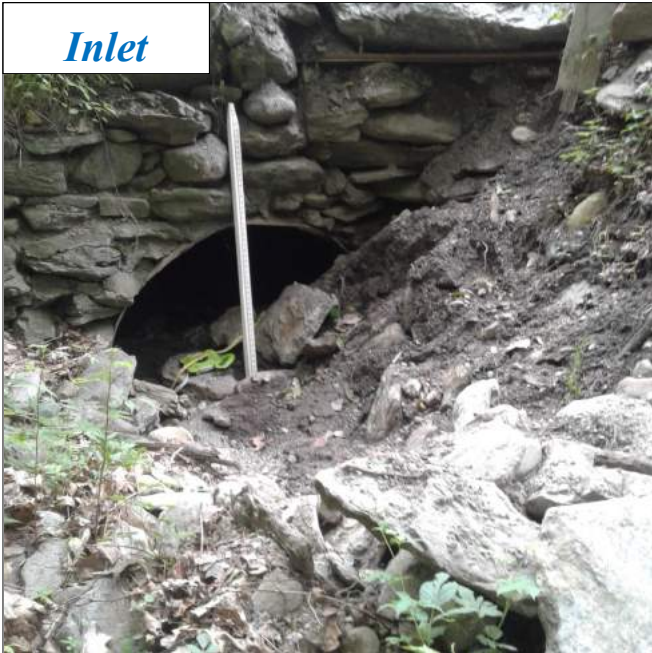
Inlet

Physical Barrier(s)/Severity: None
 Slope: 3.8%
 Structure Comments: No water is flowing through the structure

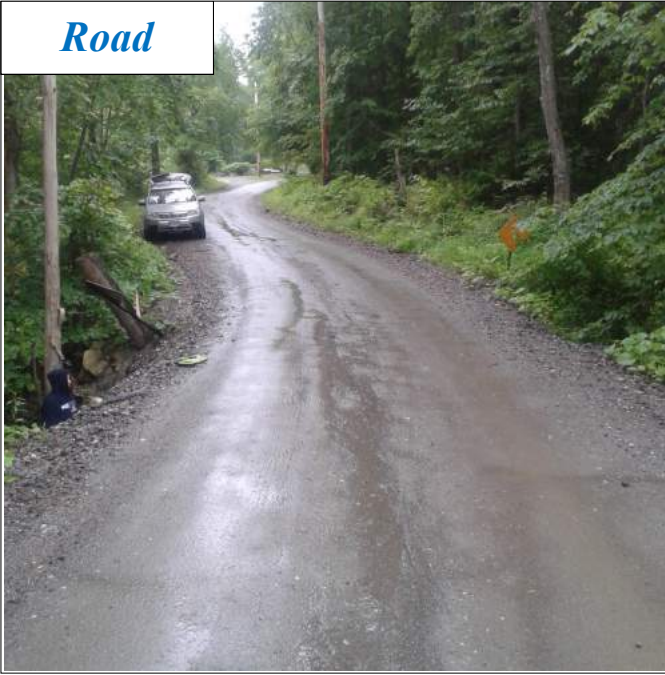
Road

Structure Comments: Outlet bottom rusted out

Washed out in Irene, structure will be replaced in 2018 and widened out

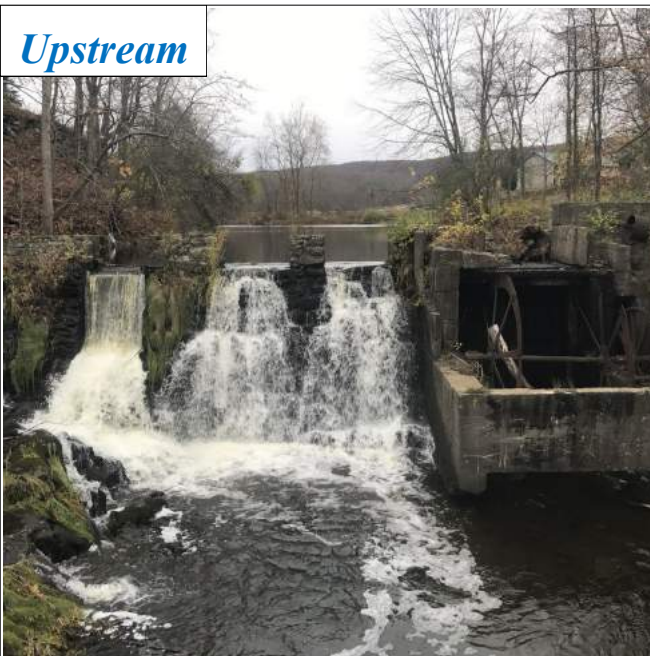
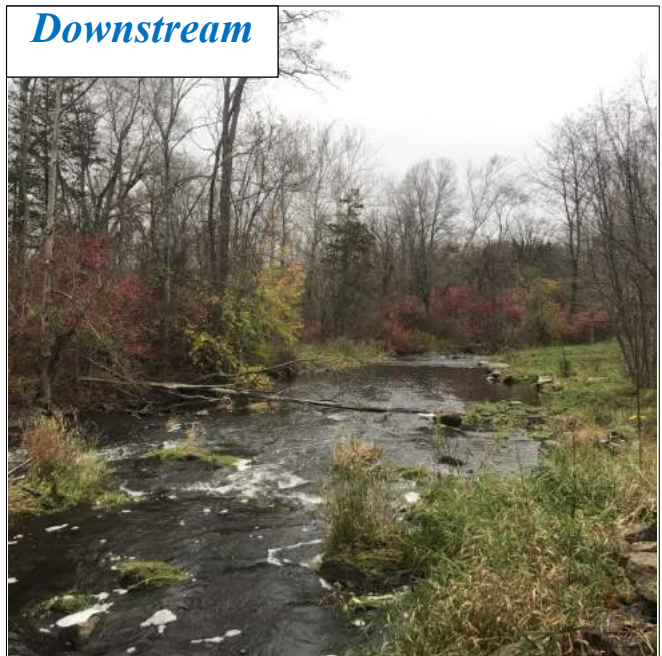
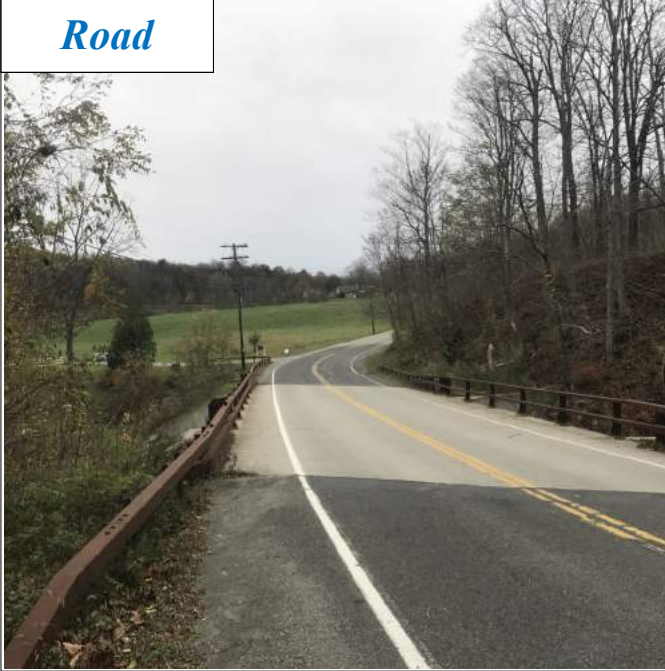
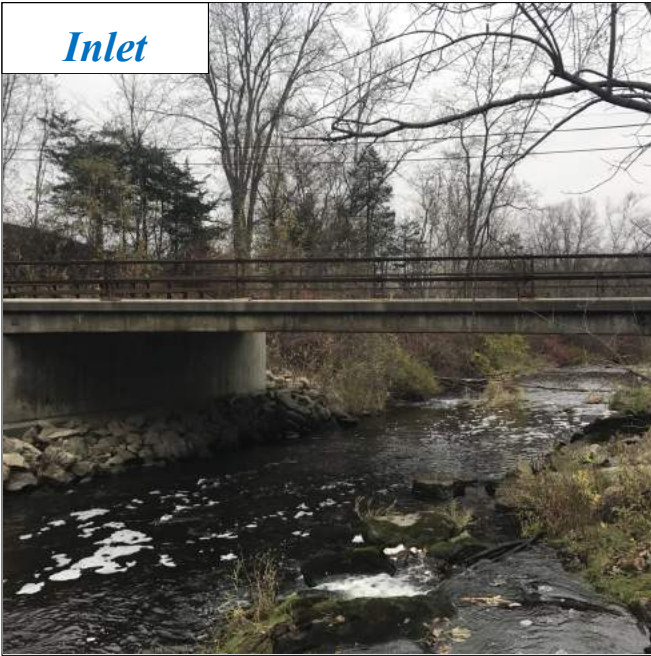
Priority for Public Safety: If that bridge fails, several families would be completely cut off from emergency services

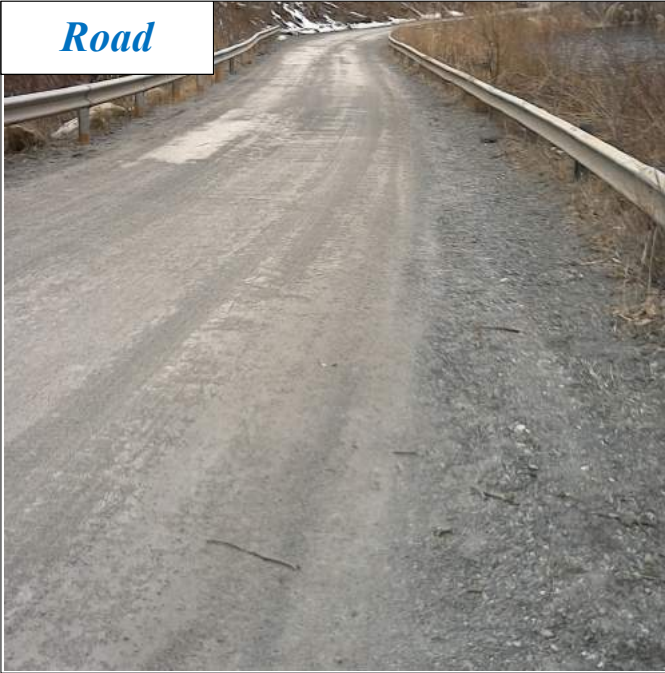
Road

Physical Barrier(s)/Severity: Debris/Sediment/
 Rock (Severe)
 Slope: 1.3%
 Structure Comments: No data

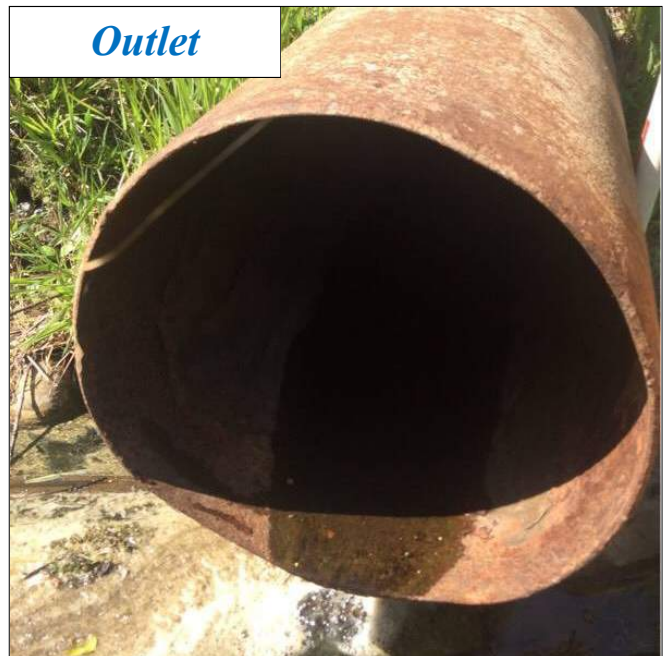
Outlet Shape: Round Culvert
 Outlet Drop/Grade: Free Fall
 Drop to Stream Surface/Bottom: 0.8/ 1.8
 Dimensions:

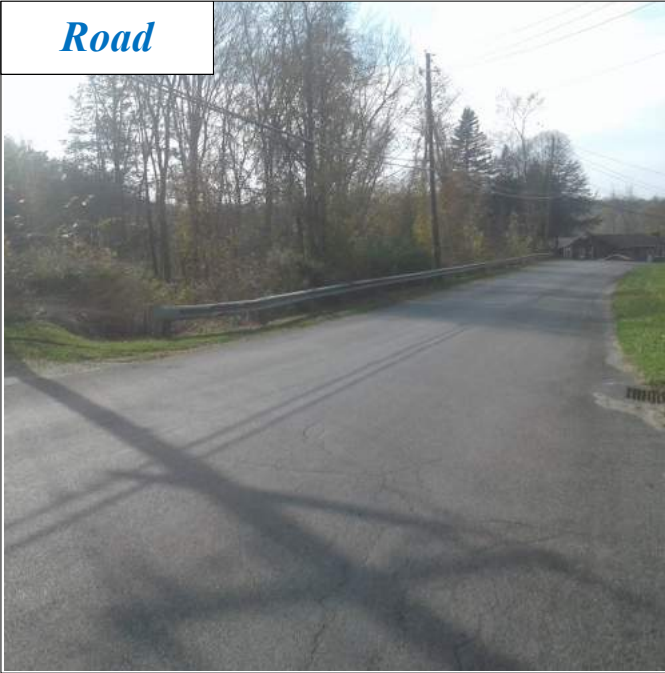
Road

Crossing Comments: Stormwater outfall at inlet and outlet

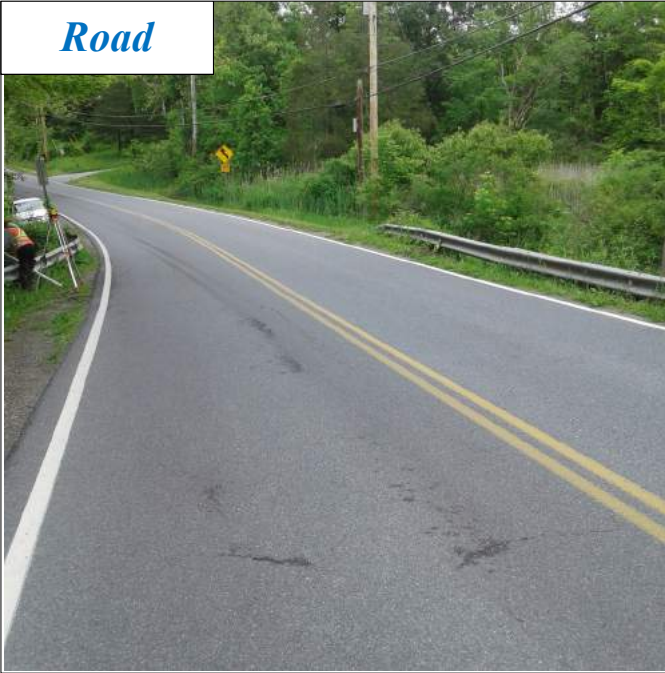
Road

**Crossing Comments:** There is another stormwater outlet culvert dropping water into the inlet

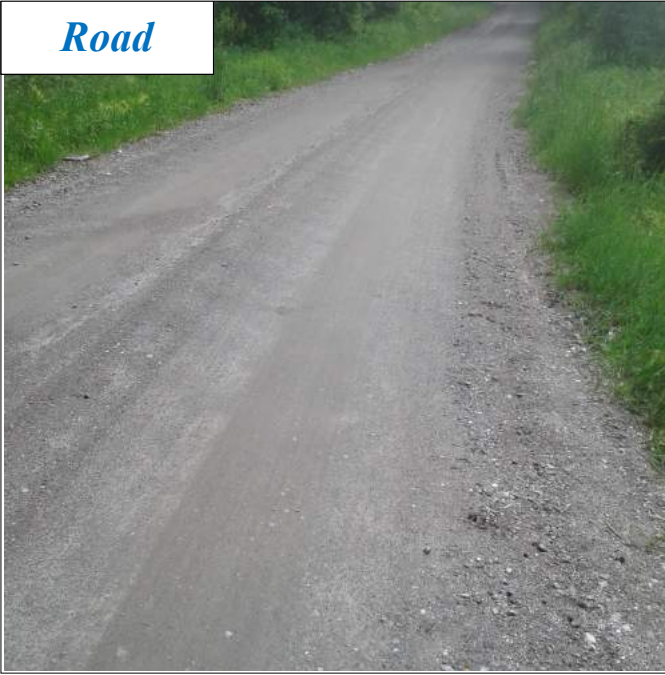
Road

Physical Barrier(s)/Severity: Deformation (Moderate)
 Slope: 2.4%
 Structure Comments: No data

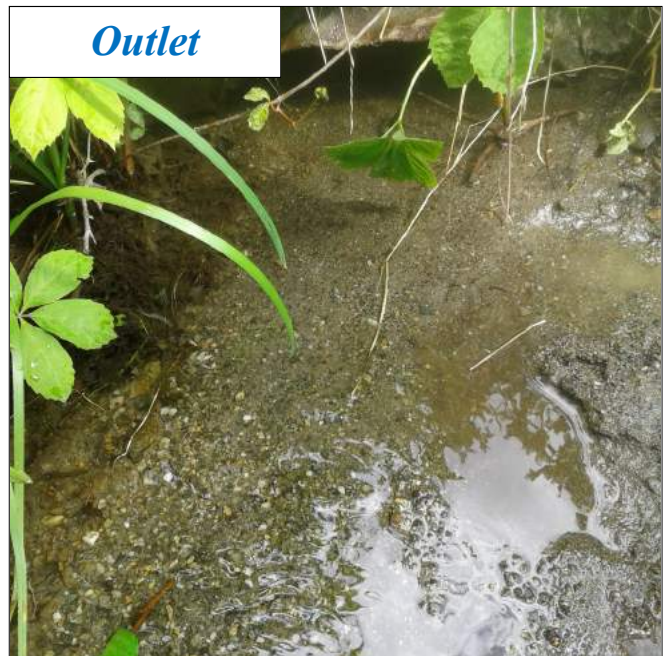
Outlet Shape: Round Culvert
 Outlet Drop/Grade: Clogged/Collapsed/Submerged
 Drop to Stream Surface/Bottom: 0.0/ 0.0
 Dimensions:

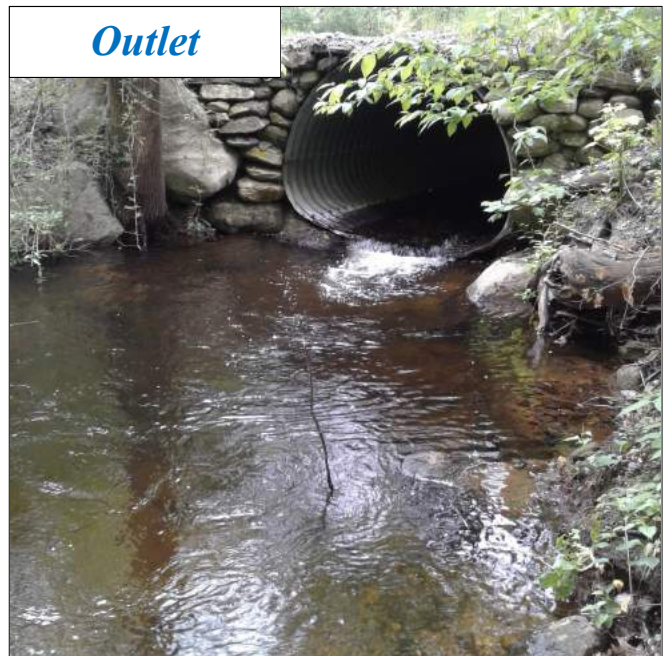
Outlet Shape: Pipe Arch/Elliptical Culvert
 Outlet Drop/Grade: Free Fall
 Drop to Stream Surface/Bottom: 0.5/ 2.3
 Dimensions:

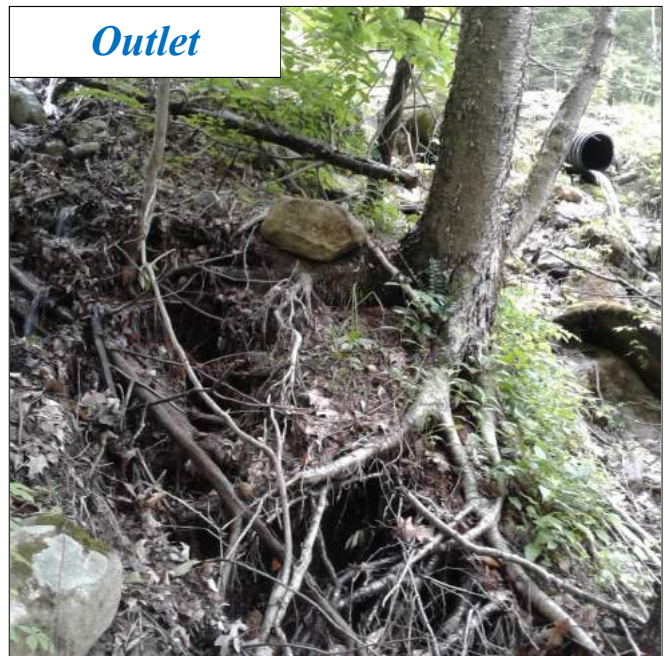
Outlet Shape: Round Culvert
Outlet Drop/Grade: Clogged/Collapsed/Submerged
Drop to Stream Surface/Bottom (feet): 0.0/0.0
Dimensions (feet):
 Width: 1.5, Height: 1.6
 Substrate/Water Width: 0.0
 Water Depth: 0.00
