Town of Dover

Road-Stream Crossing Management Plan

Produced by
The Housatonic Valley Association
2019

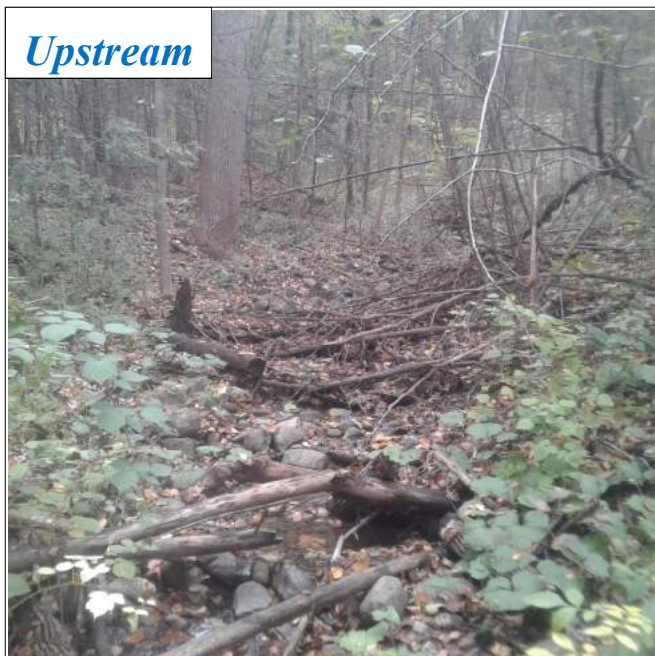
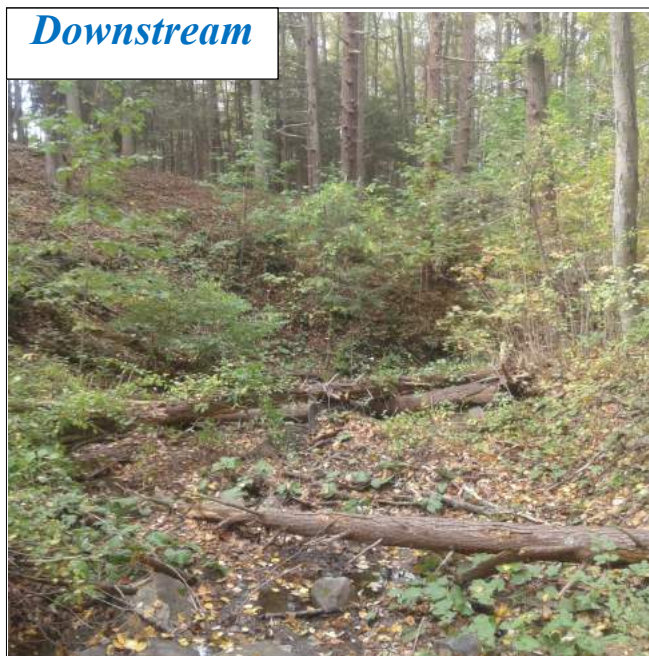
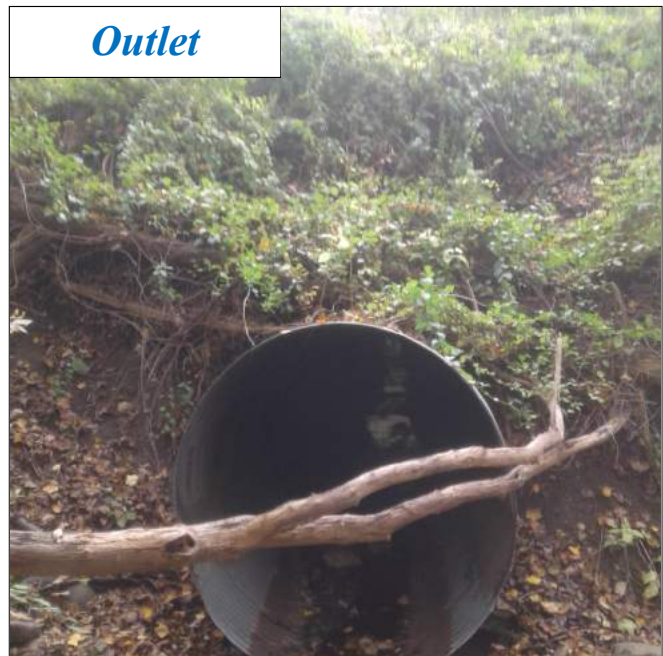
Condition: Poor

Crossing Comments: Tree fell onto section near out creating hole

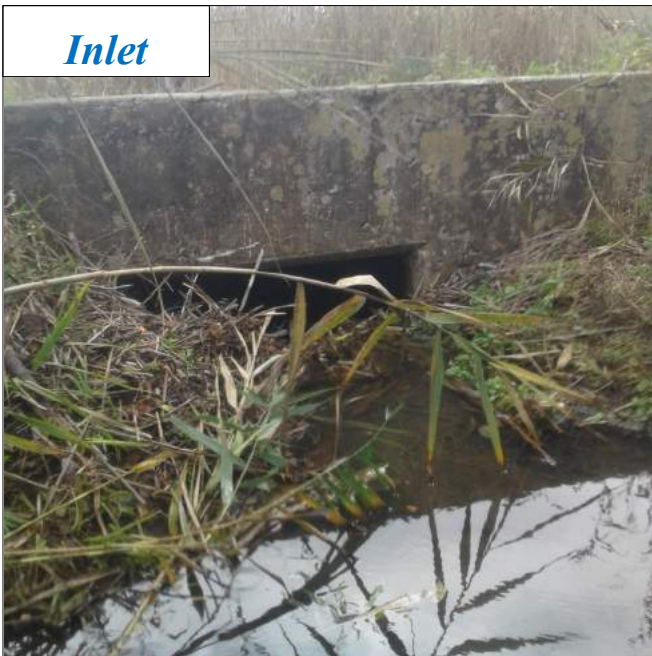
Inlet

Structure Comments: Debris in front of inlet.

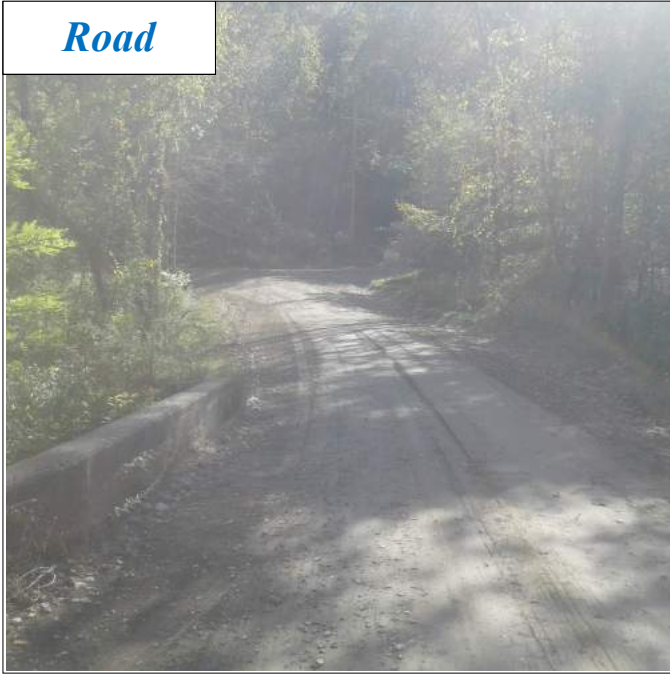
Road Type/Surface: Unpaved

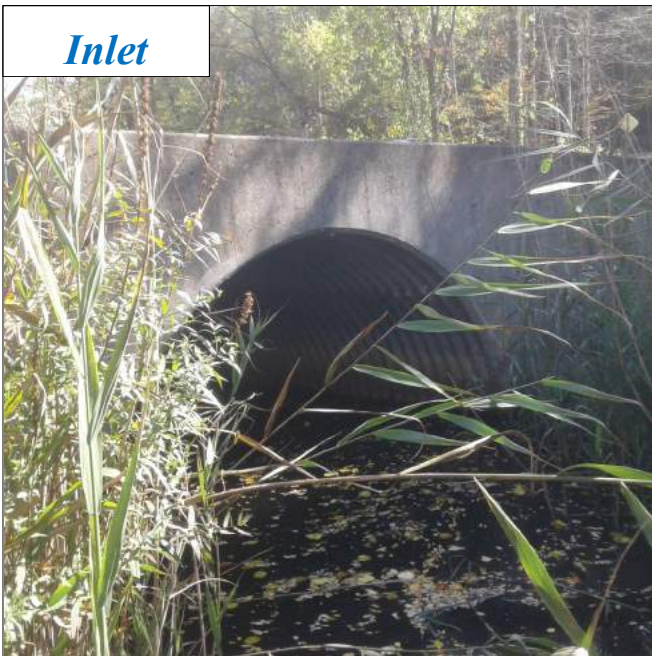
Inlet Shape/Type: Pipe Arch/Elliptical Culvert
 Inlet Drop/Grade: At Stream Grade
 Dimensions:

Width: 12.7, Height: 8.3
 Substrate/Water Width: 12.7
 Water Depth: 2.8
 Abutment Height: No data

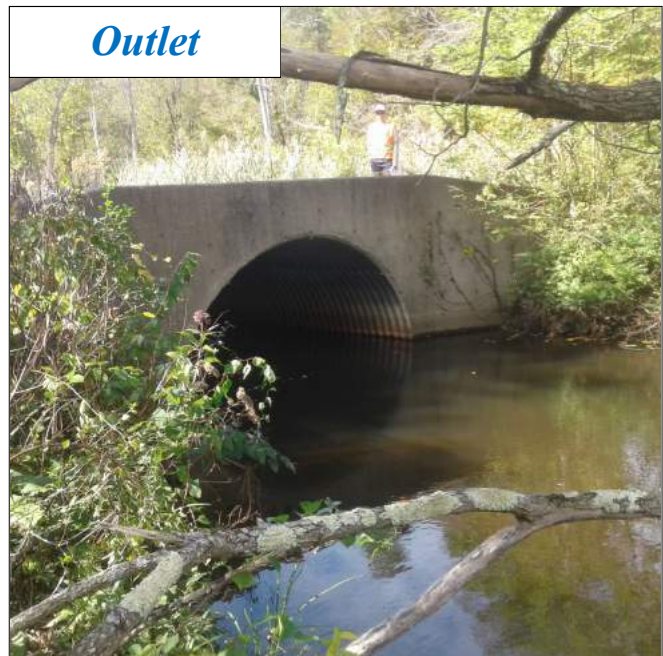
Outlet Shape: Pipe Arch/Elliptical Culvert
 Outlet Drop/Grade: At Stream Grade
 Drop to Stream Surface/Bottom: 0.0/ 0.0
 Dimensions:

Width: 12.7, Height: 8.3
 Substrate/Water Width: 12.7
 Water Depth: 2.9

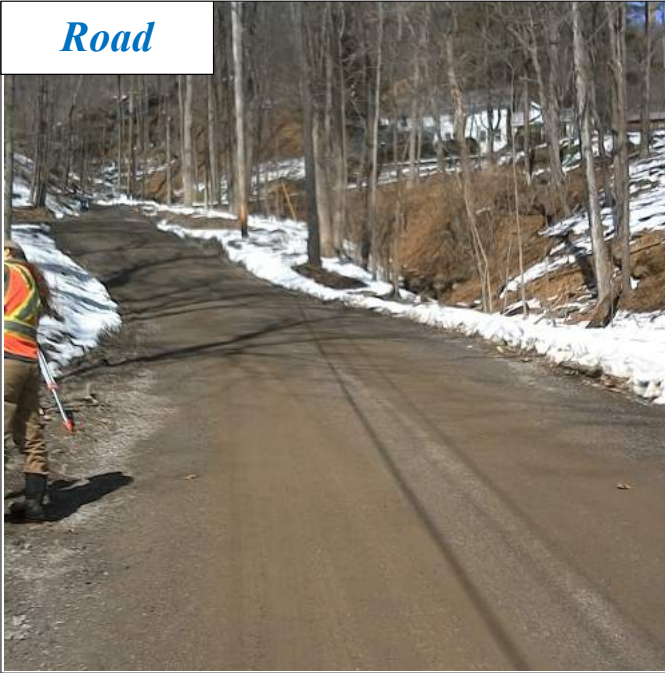
Road

Physical Barrier(s)/Severity: None
 Slope: 5.1%
 Structure Comments: No data

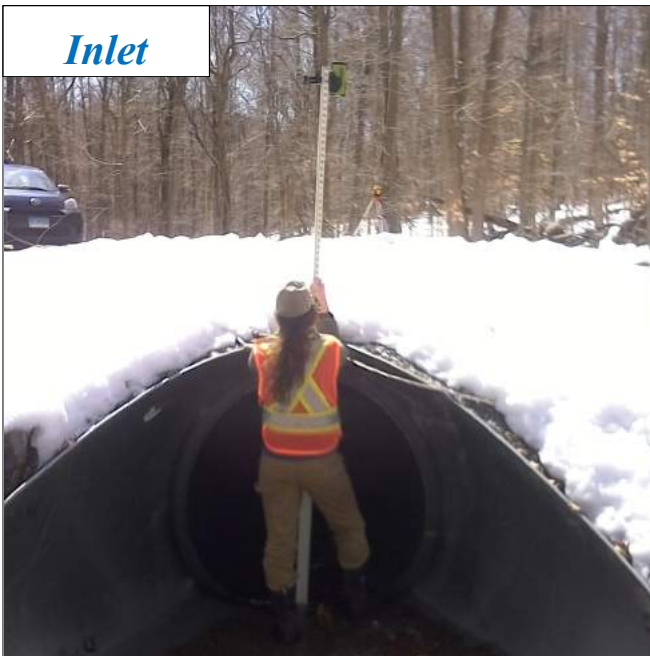
Inlet Shape/Type: Round Culvert
 Inlet Drop/Grade: At Stream Grade
 Dimensions:

Width: 3.9, Height: 4.0
 Substrate/Water Width: 1.5
 Water Depth: 0.2
 Abutment Height: No data

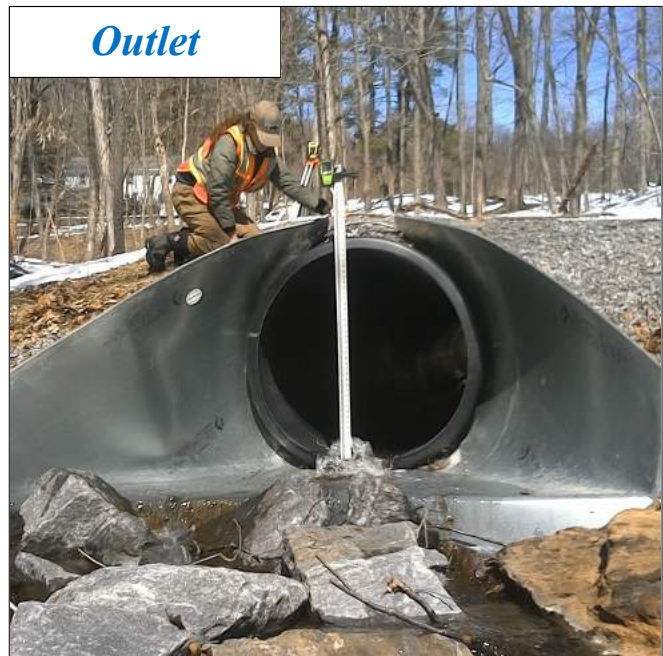
Outlet Shape: Round Culvert
 Outlet Drop/Grade: Free Fall Onto Cascade
 Drop to Stream Surface/Bottom: 0.5/ 0.9
 Dimensions:

Width: 3.9, Height: 4.0
 Substrate/Water Width: 1.3
 Water Depth: 0.1

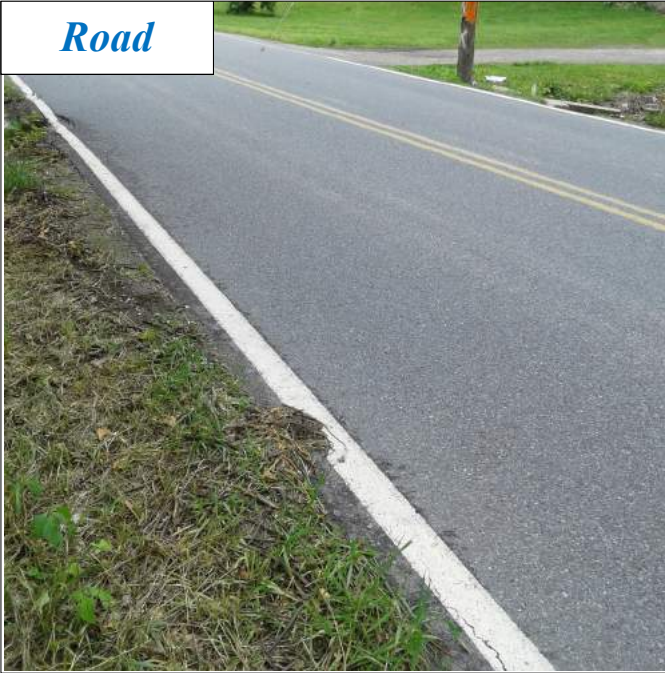
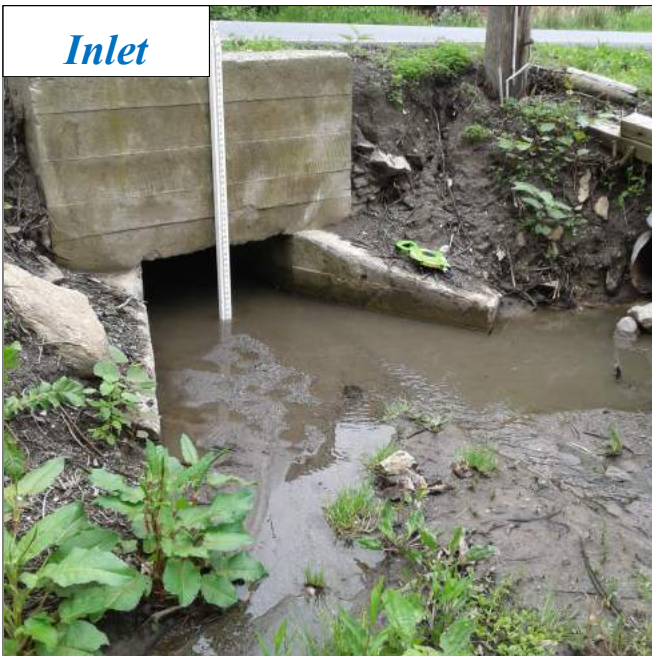
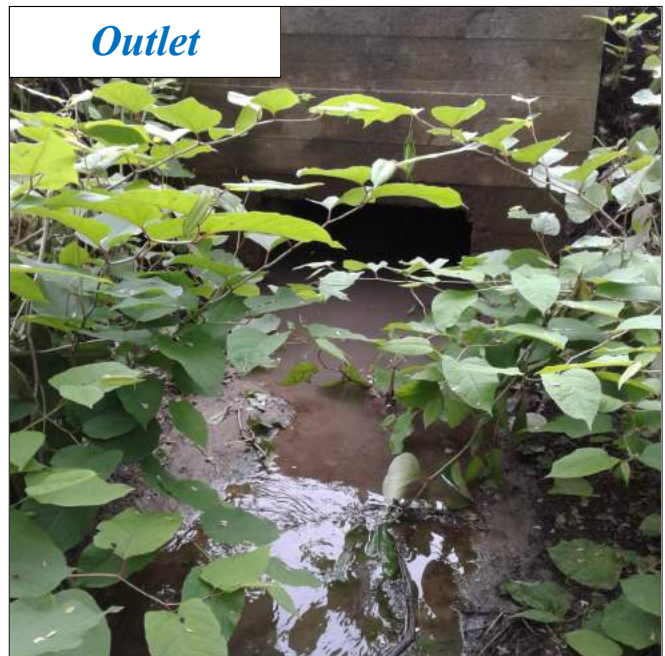
Crossing Comments: Poor Condition. Spoke to resident who believes guardrail should be added and said many accidents occur at this turn and the cars flip into the stream. Usually

Barrier Evaluation: Severe barrier

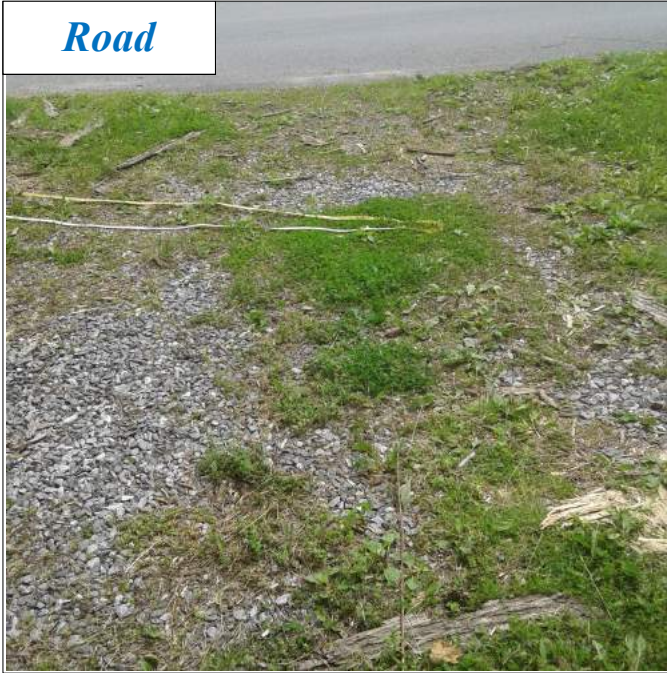
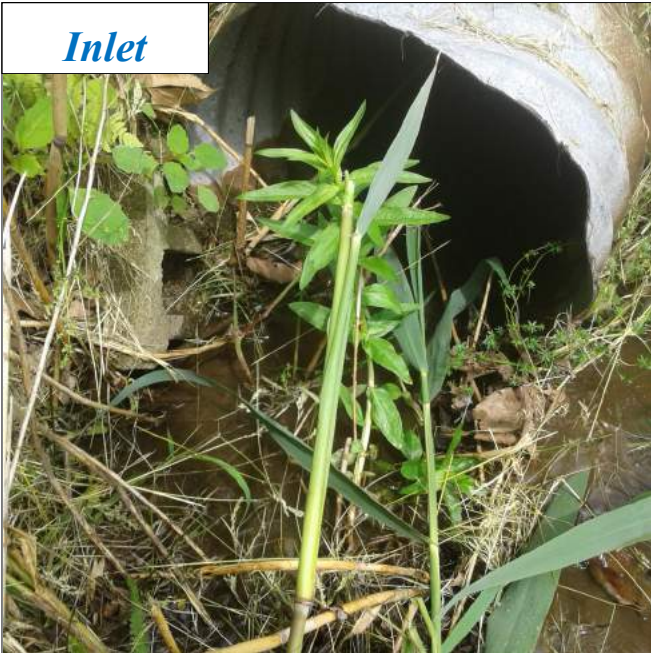
Outlet Shape: Round Culvert
 Outlet Drop/Grade: Free Fall Onto Cascade
 Drop to Stream Surface/Bottom: 1.5/ 1.6
 Dimensions:

Barrier Evaluation: Significant barrier

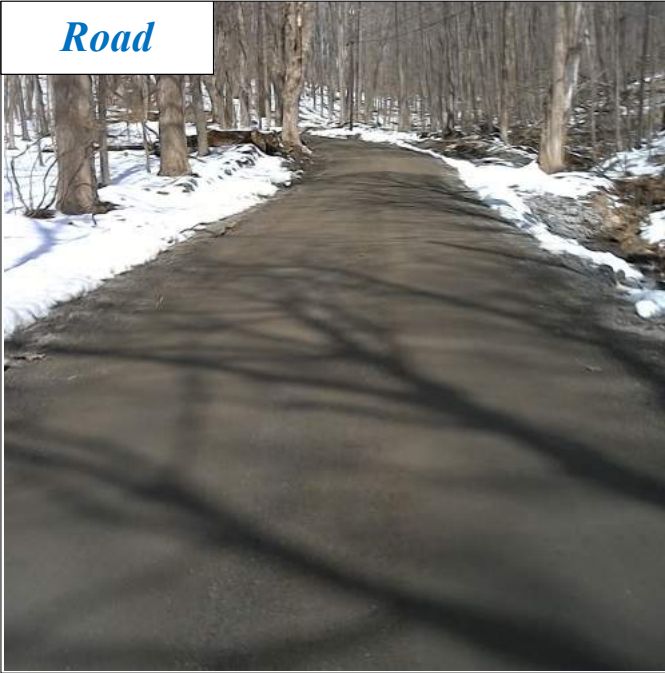
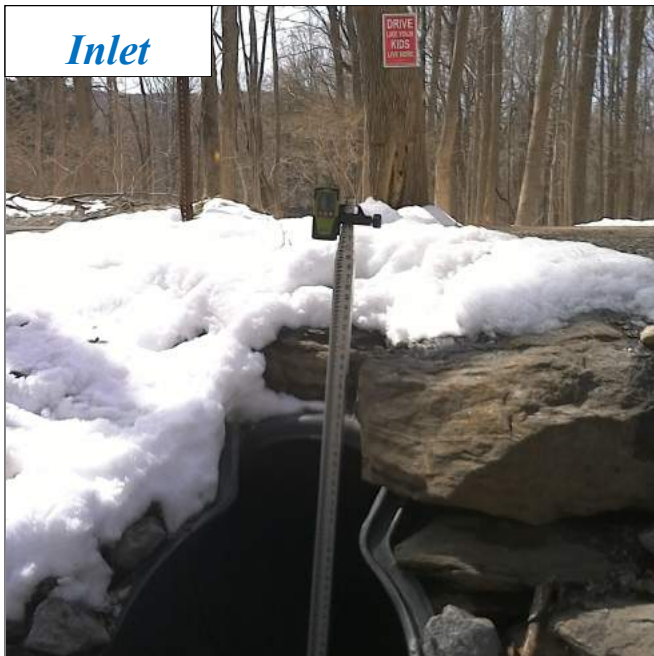
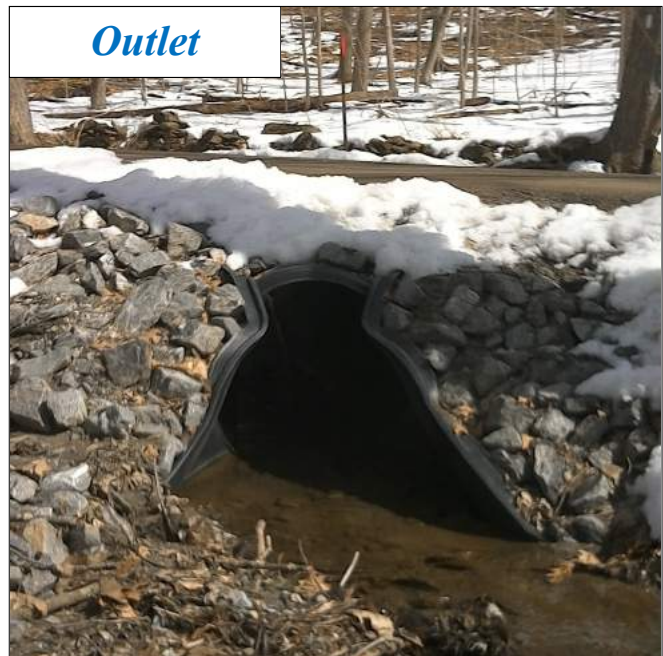
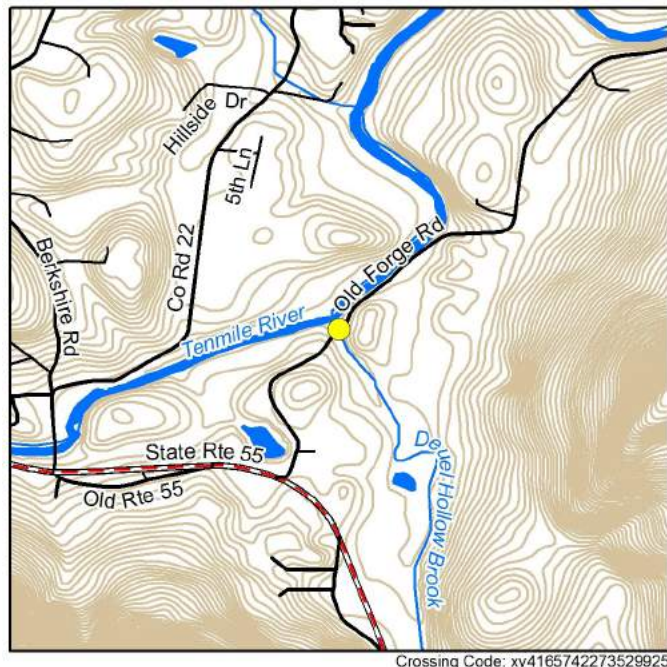
Priority for Public Safety: Public safety issue, narrow and pipe is deteriorating (would cut off people if it failed)

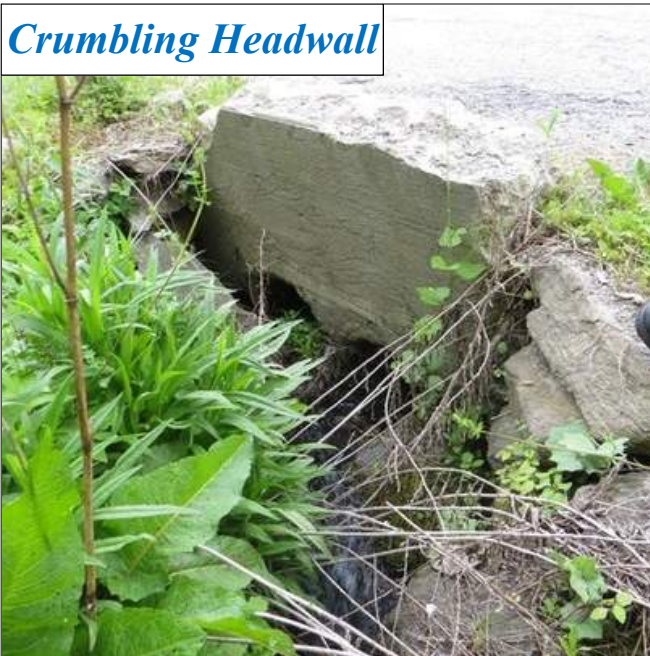
Crumbling Headwall

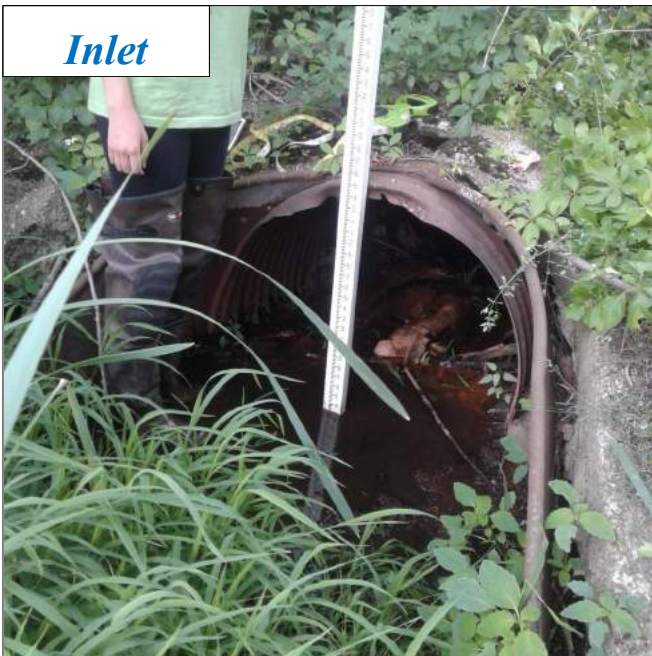
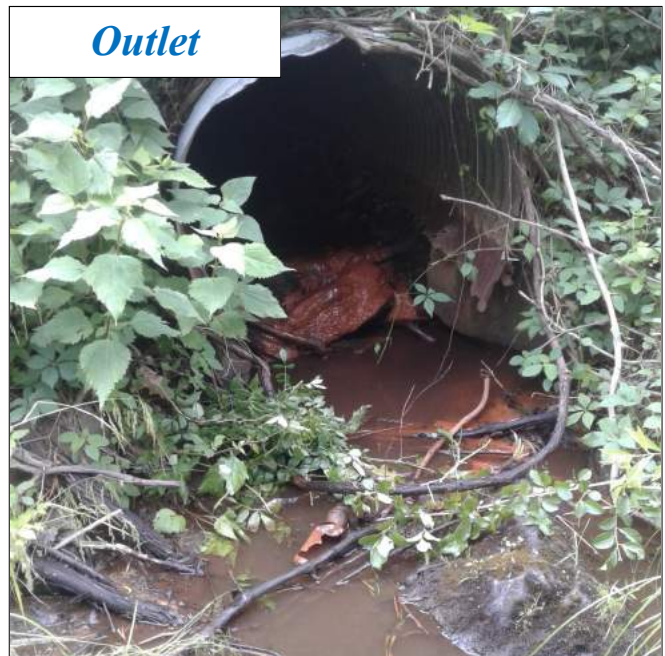
Physical Barrier(s)/Severity: None
 Slope: 0.6%
 Structure Comments: Bottom of structure is completely rusted out

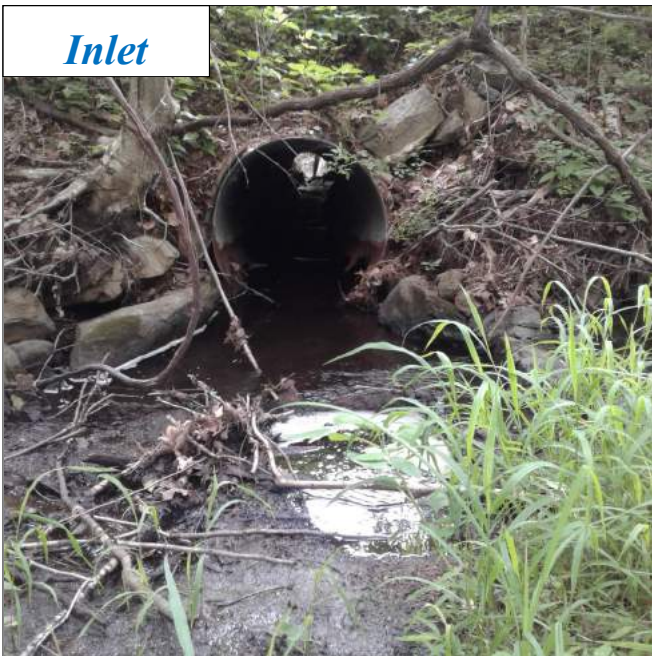
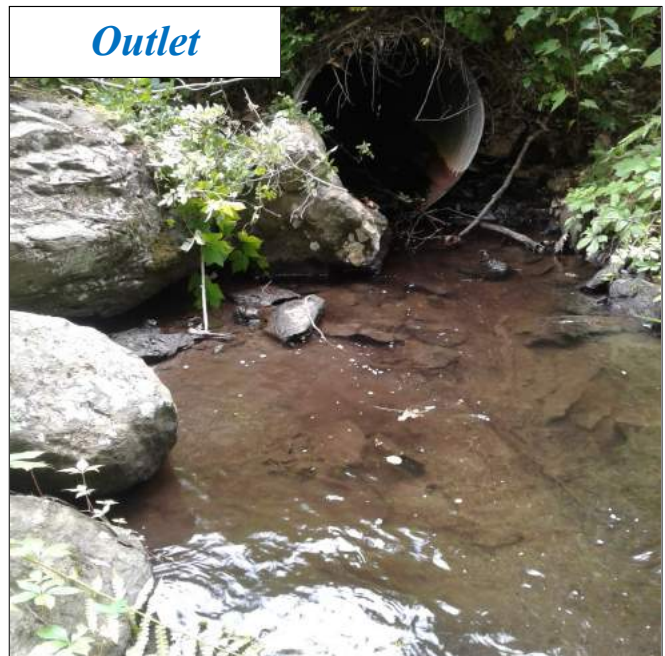
Physical Barrier(s)/Severity: None
 Slope: 2.9%
 Structure Comments: Bottom of culvert is completely rusted out the length of the pipe

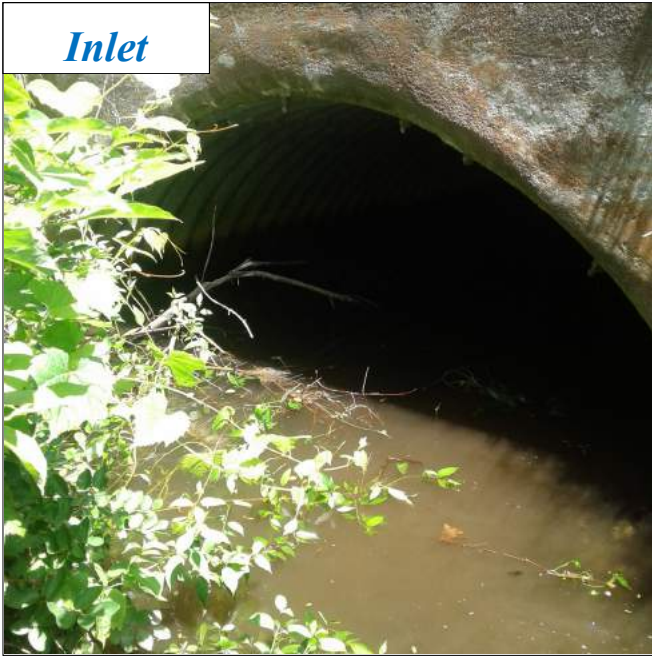
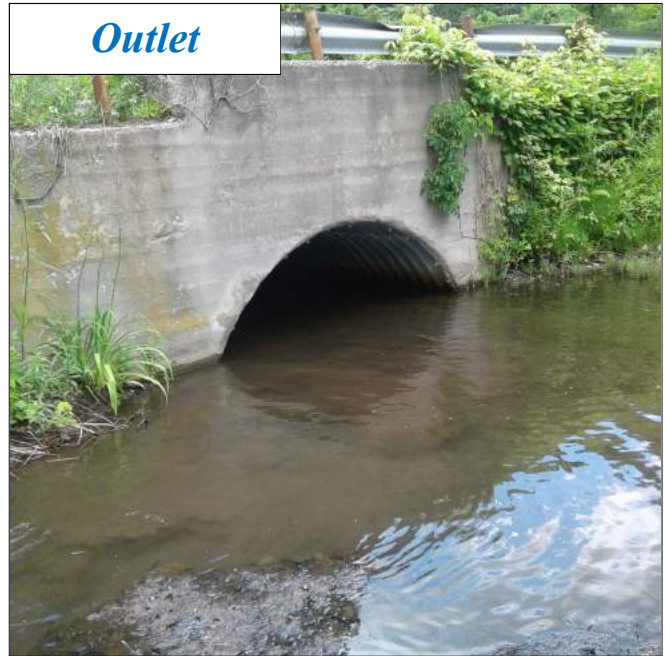
Crossing Comments: Build up of sediment throughout structure causing water to pool at the inlet

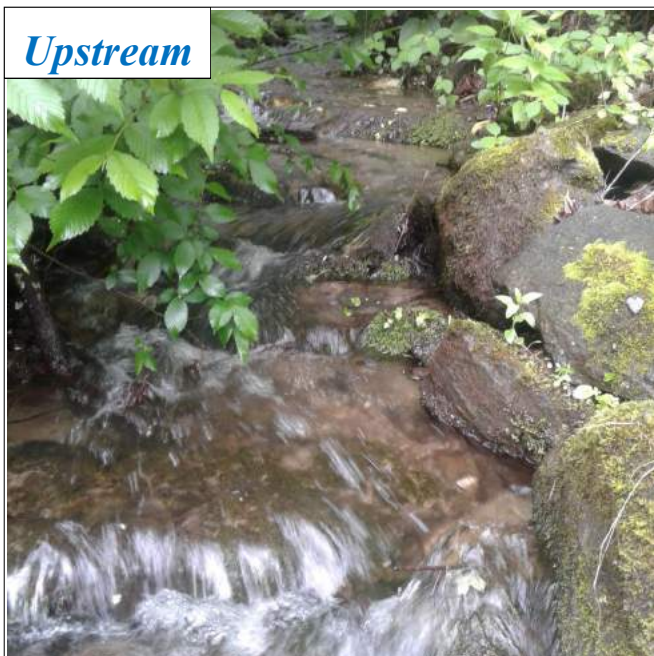
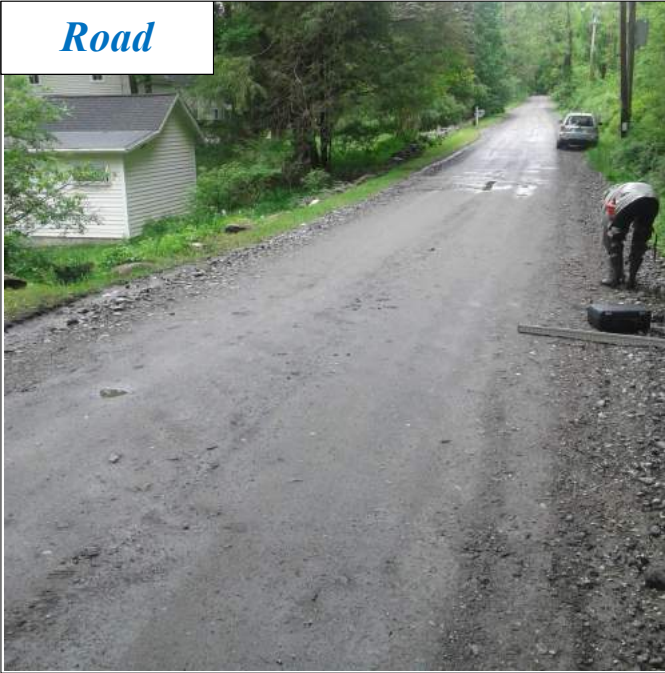
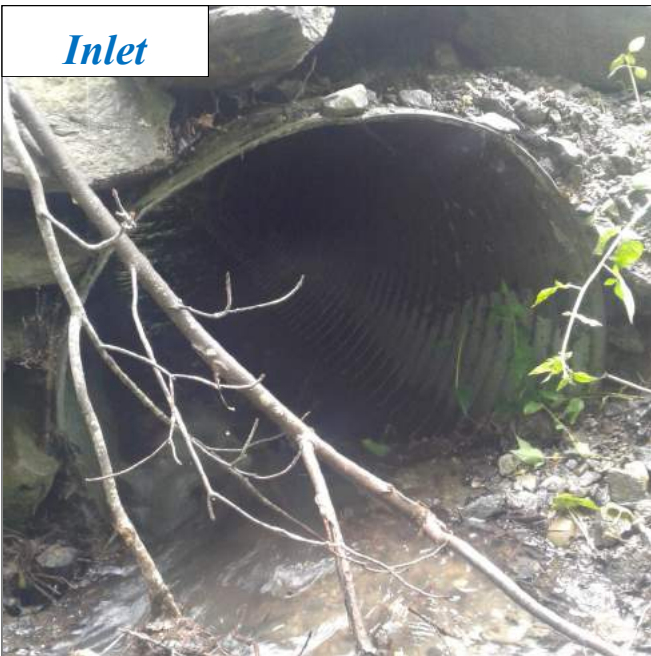
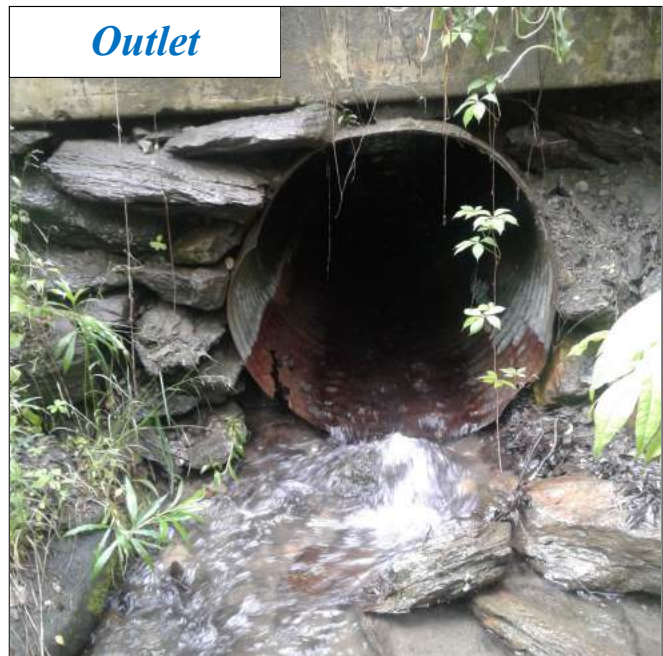
Barrier Evaluation: Minor barrier

Condition: Poor

Outlet Shape: Round Culvert
 Outlet Drop/Grade: Free Fall
 Drop to Stream Surface/Bottom: 0.1/ 0.3
 Dimensions:

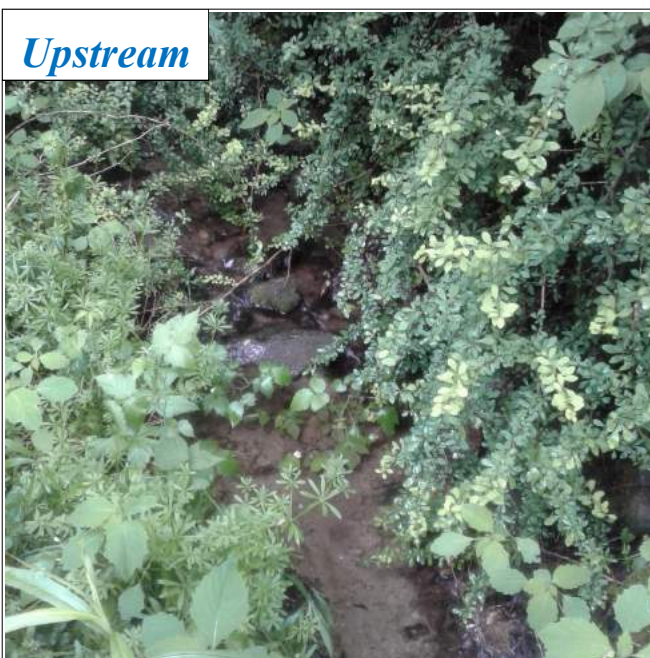
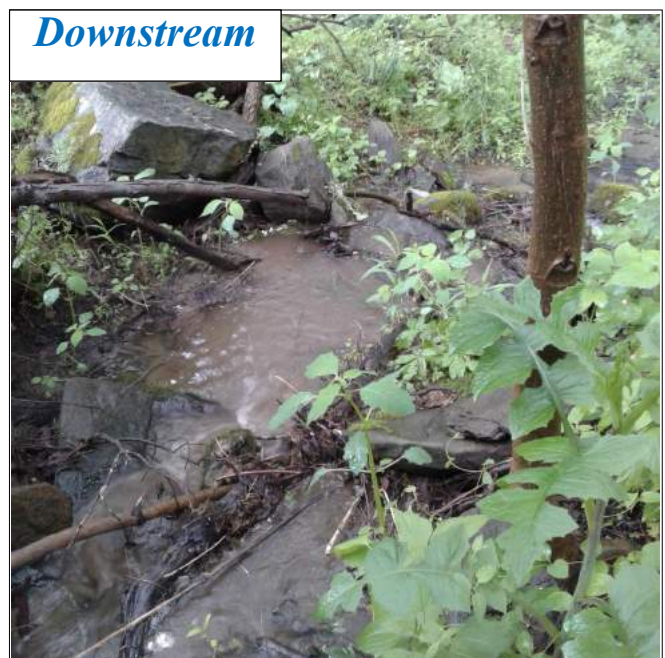
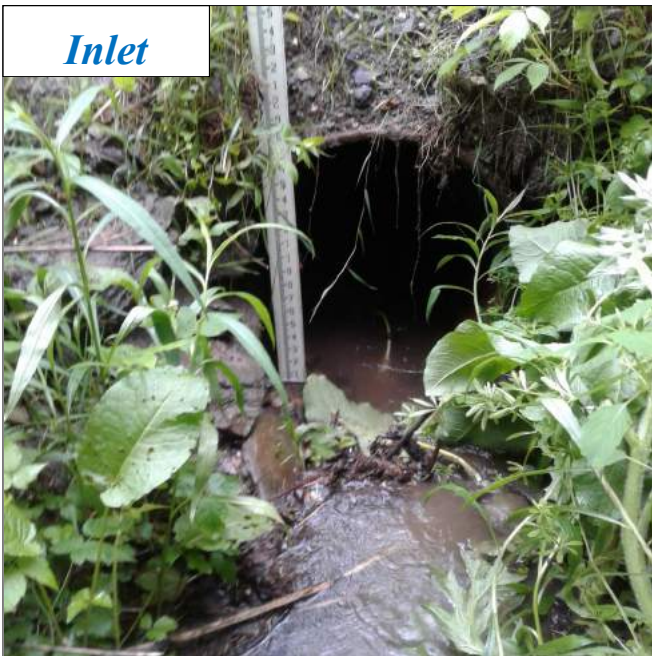
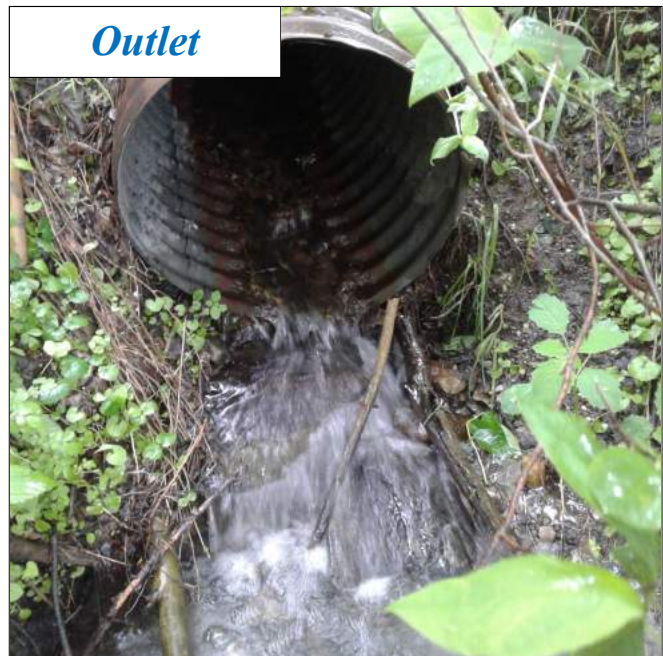
Barrier Evaluation: Significant barrier

Condition: Poor

Outlet Shape: Round Culvert
 Outlet Drop/Grade: Free Fall Onto Cascade
 Drop to Stream Surface/Bottom: 0.8/ 0.9
 Dimensions:

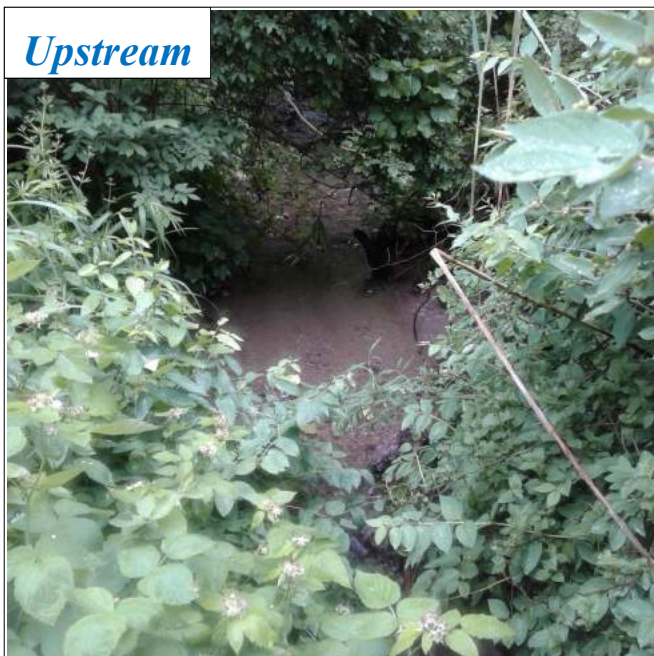
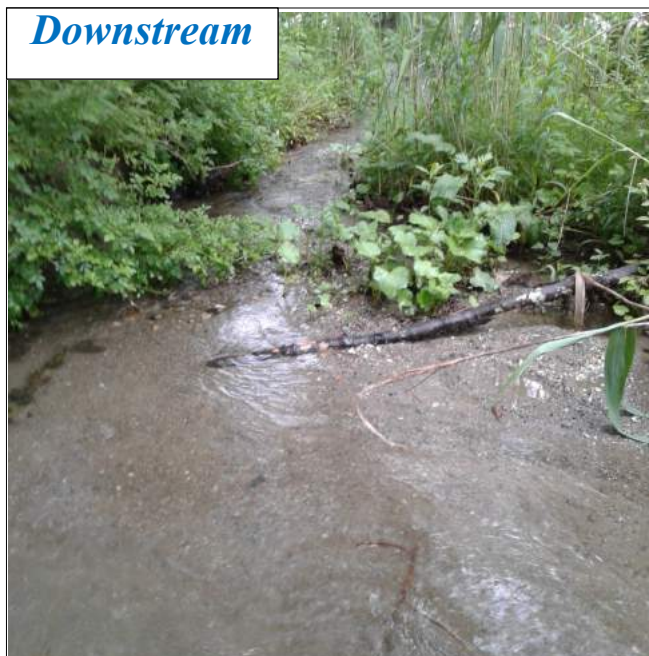
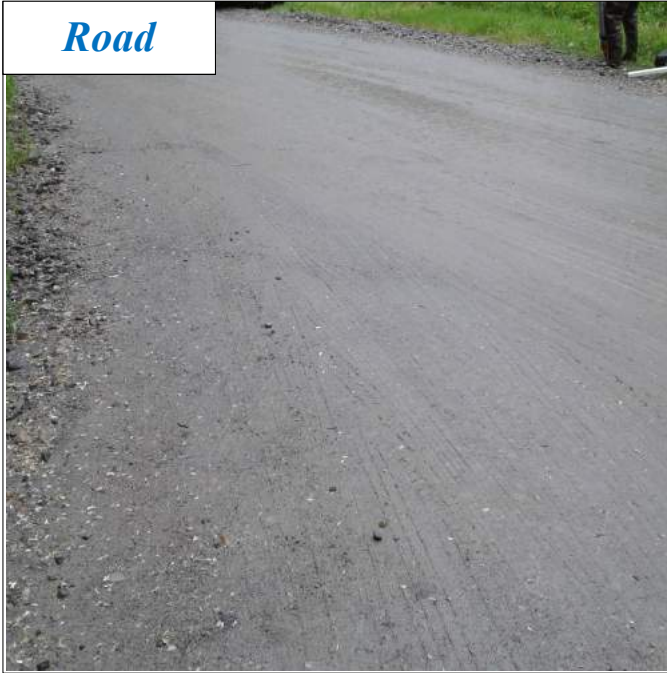
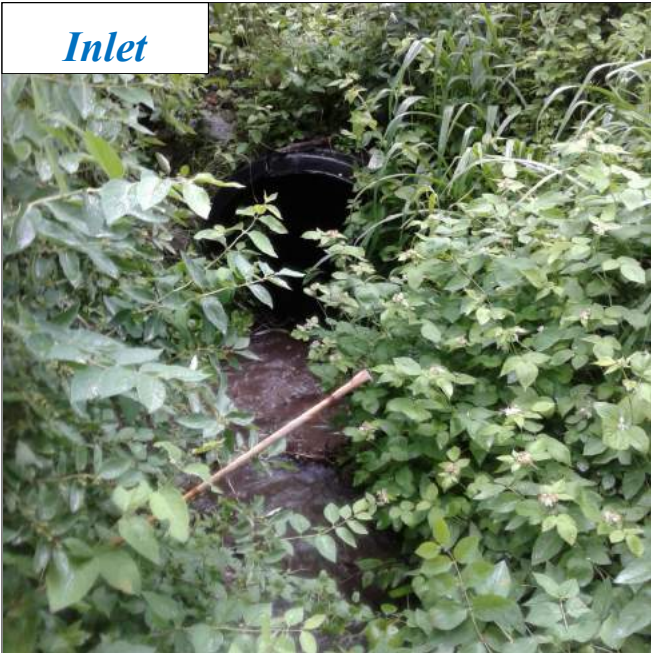
Barrier Evaluation: Moderate barrier

Road gets damaged by flooding (avulsion)

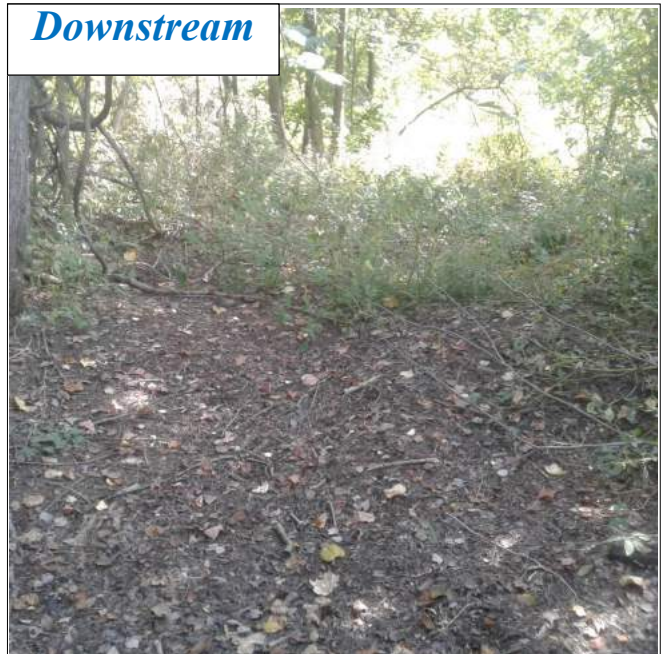
***Downstream***

Crossing Comments: Railroad crossing 20 ft upstream

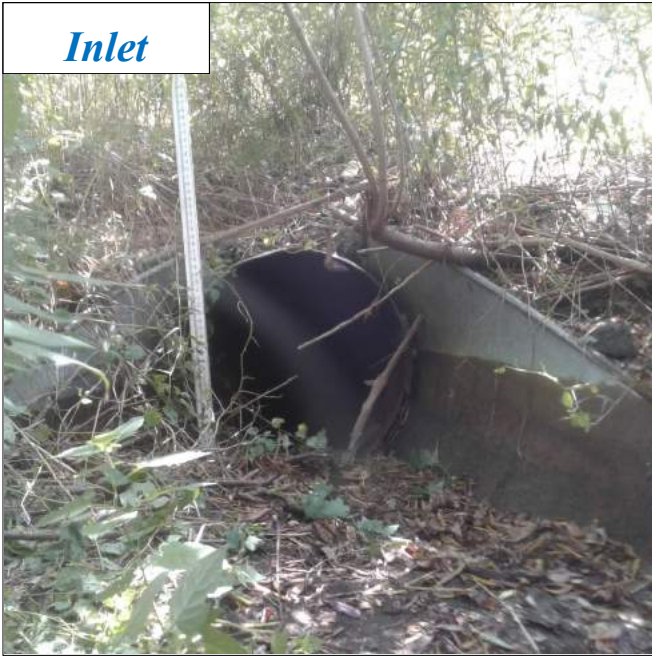
Inlet Shape/Type: Round Culvert
 Inlet Drop/Grade: At Stream Grade
 Dimensions:
 Width: 3.0, Height: 3.0
 Substrate/Water Width: 0.0
 Water Depth: 0.0
 Abutment Height: No data

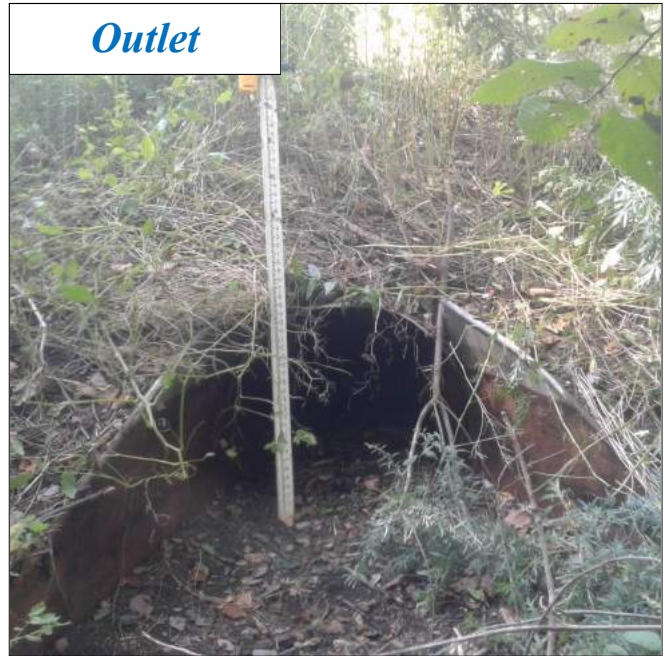
Outlet Shape: Round Culvert
 Outlet Drop/Grade: At Stream Grade
 Drop to Stream Surface/Bottom: 0.0/ 0.0
 Dimensions:
 Width: 2.8, Height: 2.4
 Substrate/Water Width: 2.6
 Water Depth: 0.0

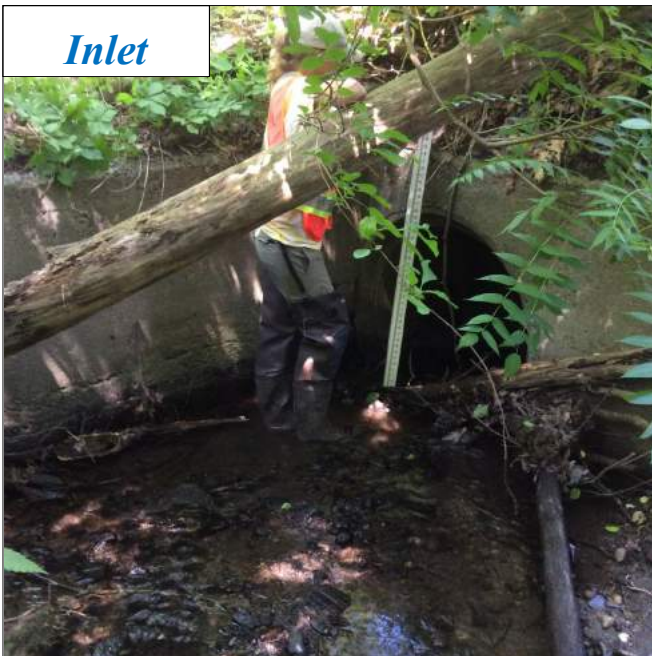
Inlet Shape/Type: Round Culvert
 Inlet Drop/Grade: At Stream Grade
 Dimensions:

Width: 3.0, Height: 3.0
 Substrate/Water Width: 1.5
 Water Depth: 0.1
 Abutment Height: No data

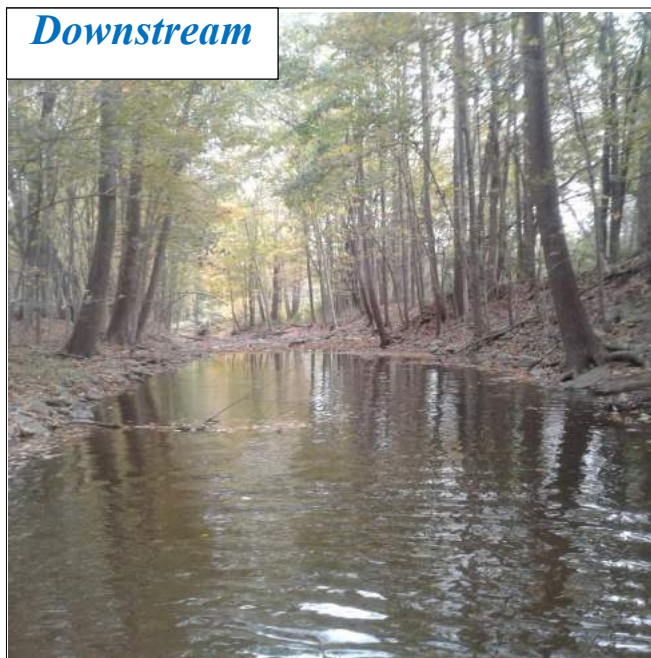
Downstream

Crossing Comments: Old Bridge support in stream.

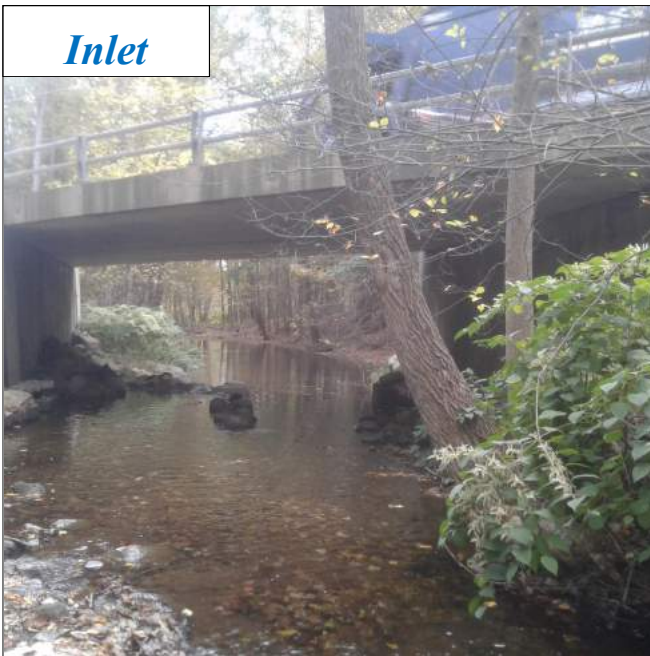
Inlet Shape/Type: Box/Bridge with Abutments
Inlet Drop/Grade: At Stream Grade
Dimensions:
Width: 45.5, Height: 13.5
Substrate/Water Width: 45.5
Water Depth: 1.2
Abutment Height: No data

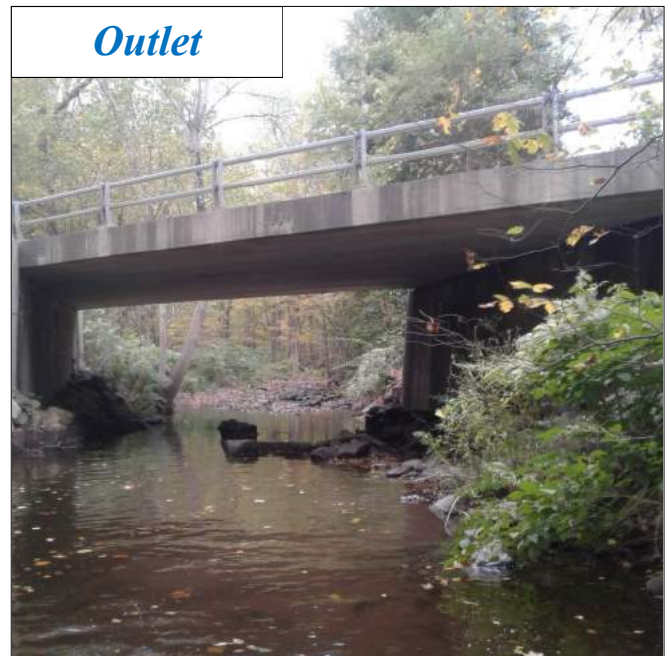
Outlet Shape: Box/Bridge with Abutments
Outlet Drop/Grade: At Stream Grade
Drop to Stream Surface/Bottom: 0.0/ 0.0
Dimensions:
Width: 45.6, Height: 14.6
Substrate/Water Width: 45.6
Water Depth: 2.8

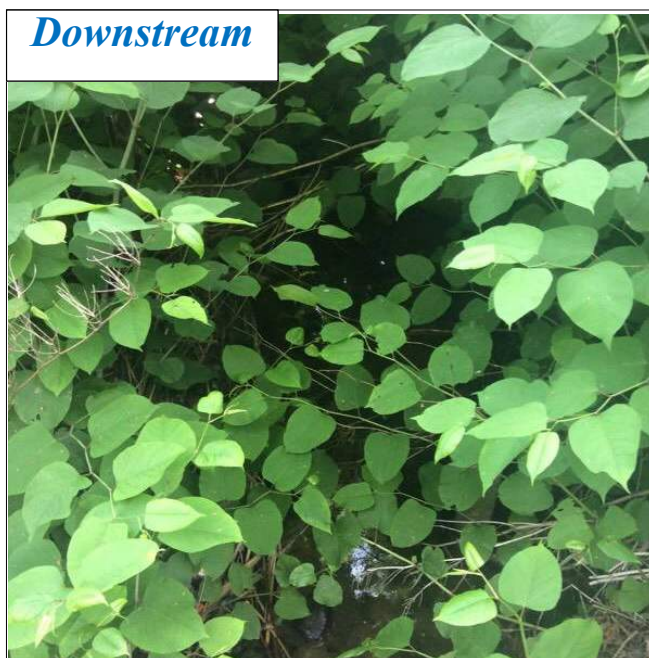
Downstream

Crossing Comments: Inlet is metal and concrete

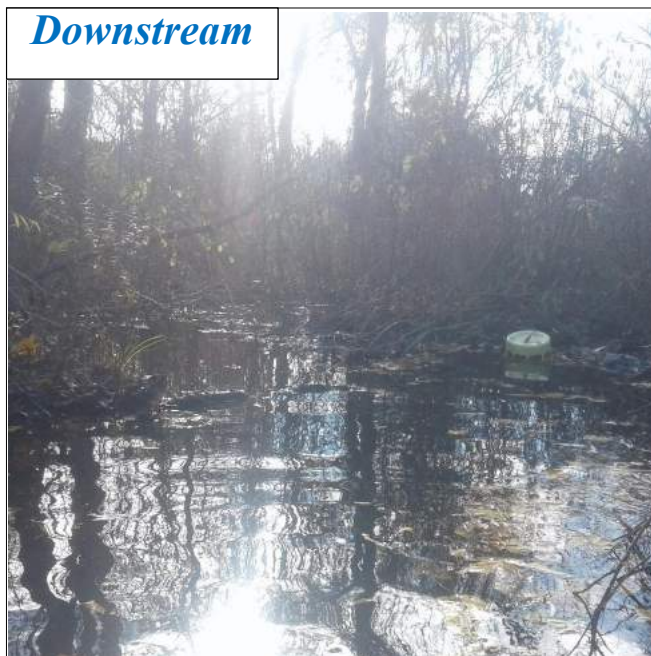
Downstream

Crossing Comments: Upstream flows through stone wall

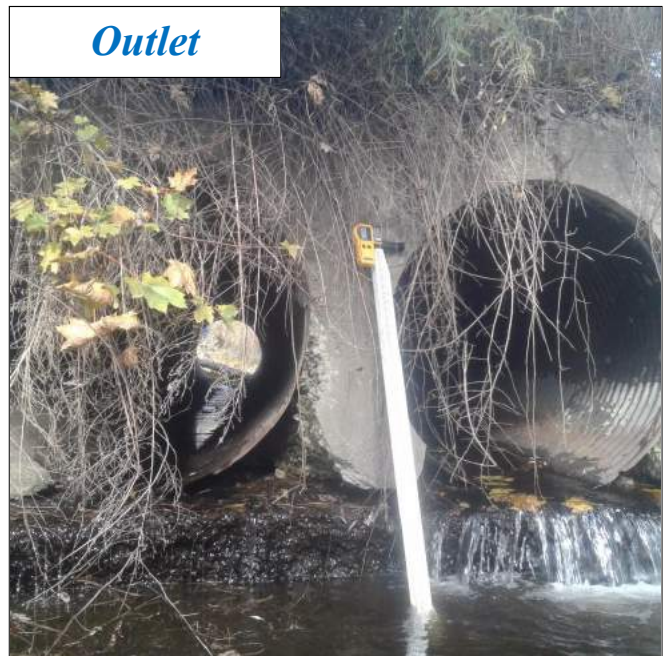
Outlet Shape: Round Culvert
 Outlet Drop/Grade: Free Fall
 Drop to Stream Surface/Bottom: 0.9/ 1.8
 Dimensions:

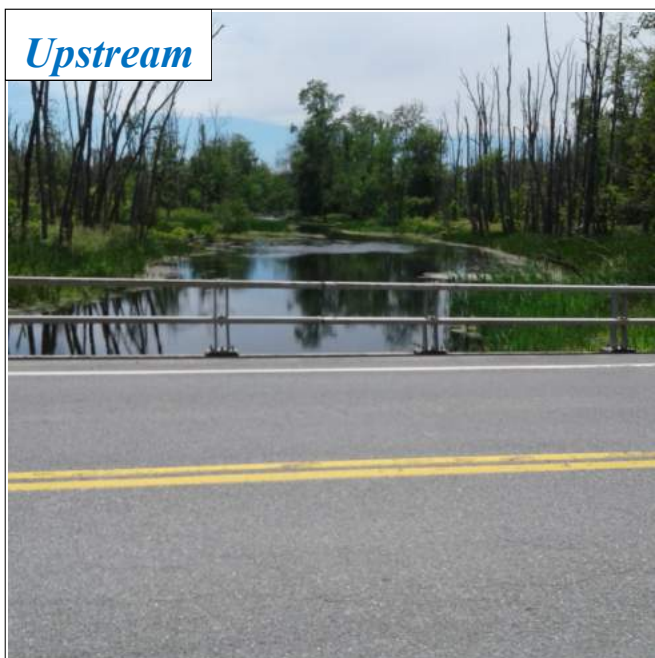
Crossing Comments: Upstream area is a swamp, bankfull width is estimated

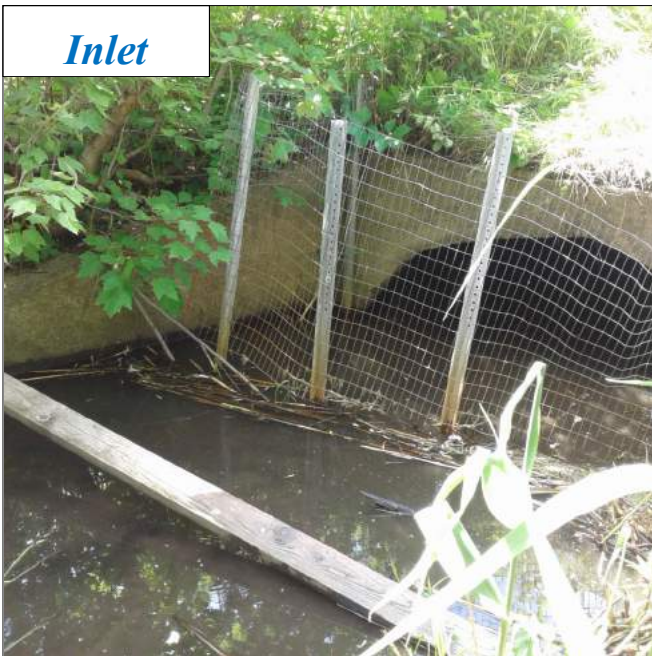
Inlet

Structure Comments: There is a wire fence at the inlet, but there is a 1-foot gap between by the

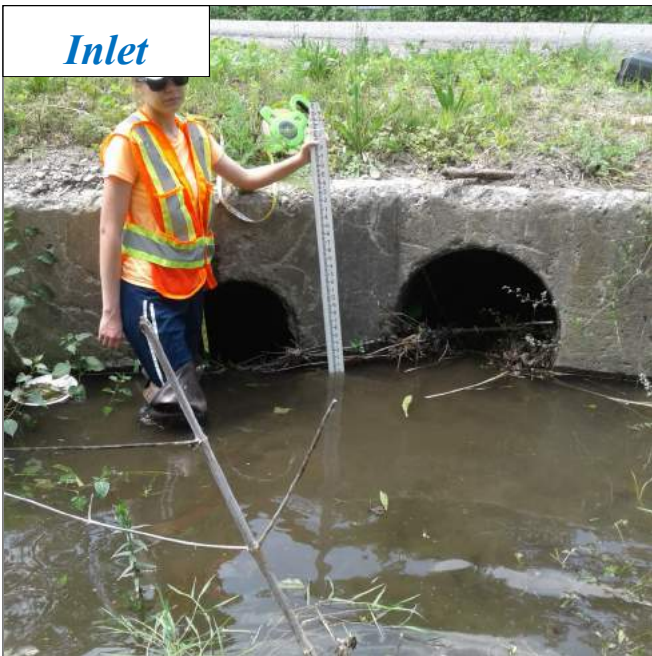
Physical Barrier(s)/Severity: Debris/Sediment/
 Rock (Moderate)
 Slope: 3.9%
 Structure Comments: No data

Inlet Shape/Type: Round Culvert
 Inlet Drop/Grade: Perched
 Dimensions:
 Width: 1.5, Height: 1.6
 Substrate/Water Width: 0.9
 Water Depth: 0.1
 Abutment Height: No data
