Town of Dover

Road-Stream Crossing Management Plan

Produced by
The Housatonic Valley Association
2019

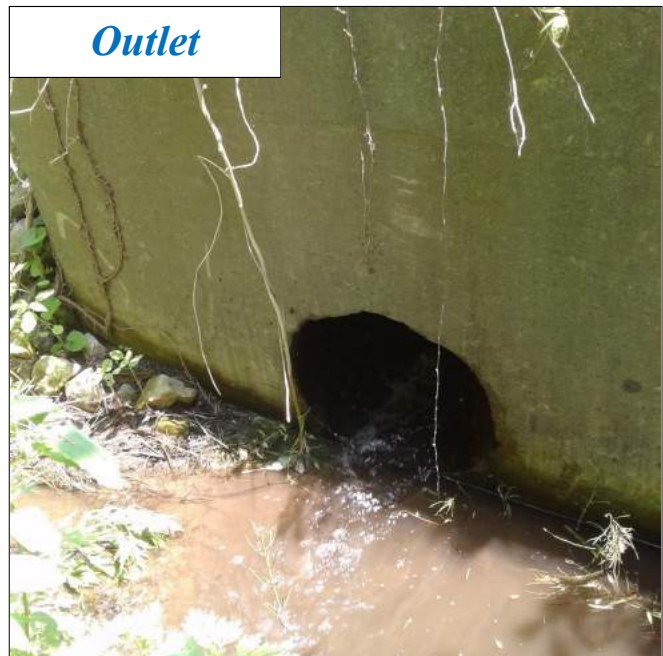
Outlet Shape: Round Culvert
 Outlet Drop/Grade: Free Fall
 Drop to Stream Surface/Bottom: 0.1/ 0.4
 Dimensions:
 Width: 1.6, Height: 1.5
 Substrate/Water Width: 1.1
 Water Depth: 0.1

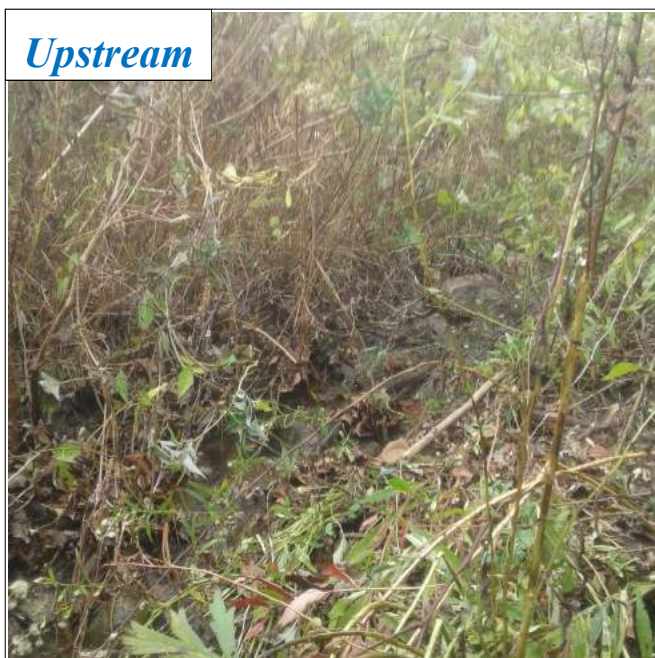
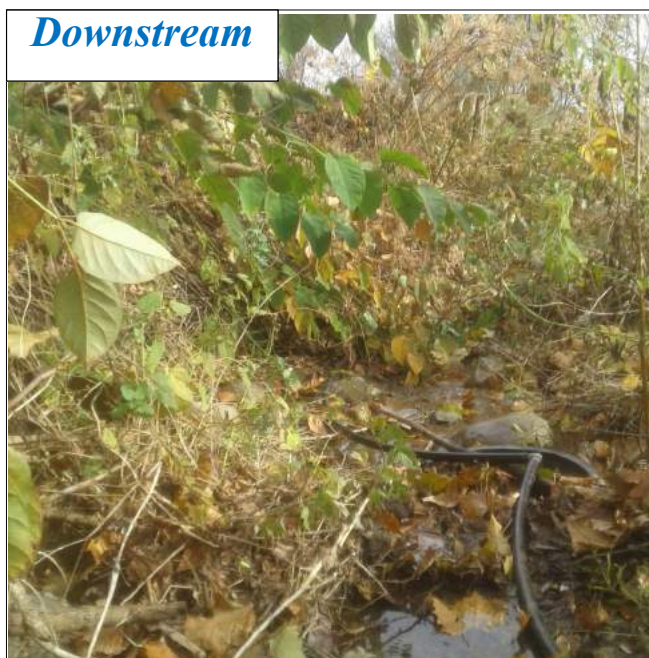
Crossing Comments: Electric fence and plastic pipe outfall 50 upstream. rubber hose runs through culvert

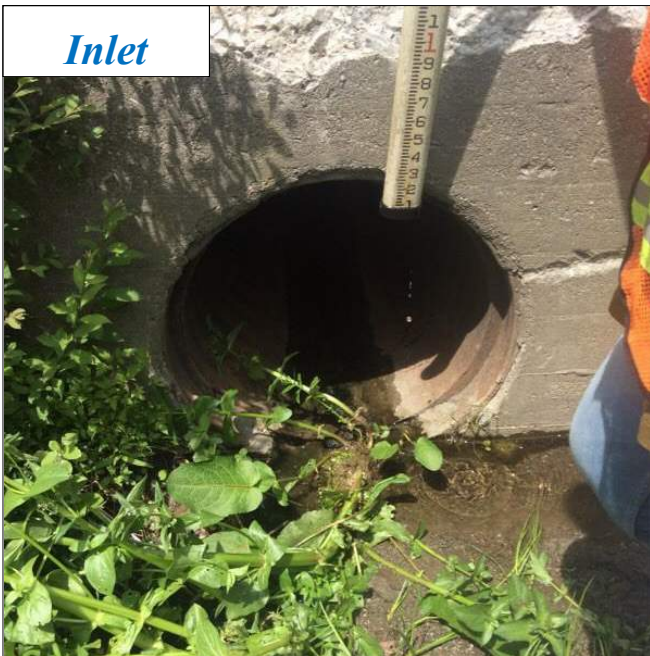
Inlet Shape/Type: Round Culvert
 Inlet Drop/Grade: Perched
 Dimensions:
 Width: 2.0, Height: 2.0
 Substrate/Water Width: 0.6
 Water Depth: 0.1
 Abutment Height: No data

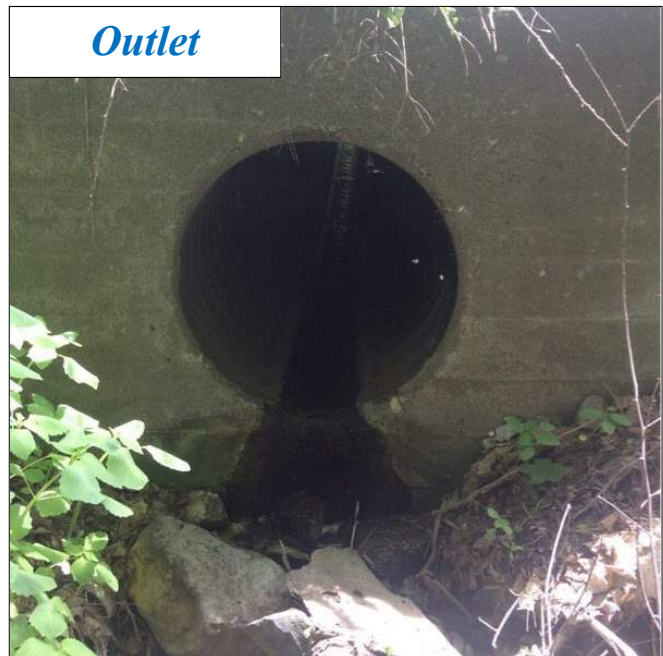
Outlet Shape: Round Culvert
 Outlet Drop/Grade: Free Fall Onto Cascade
 Drop to Stream Surface/Bottom: 2.0/ 2.1
 Dimensions:
 Width: 2.0, Height: 2.0
 Substrate/Water Width: 0.5
 Water Depth: 0.1

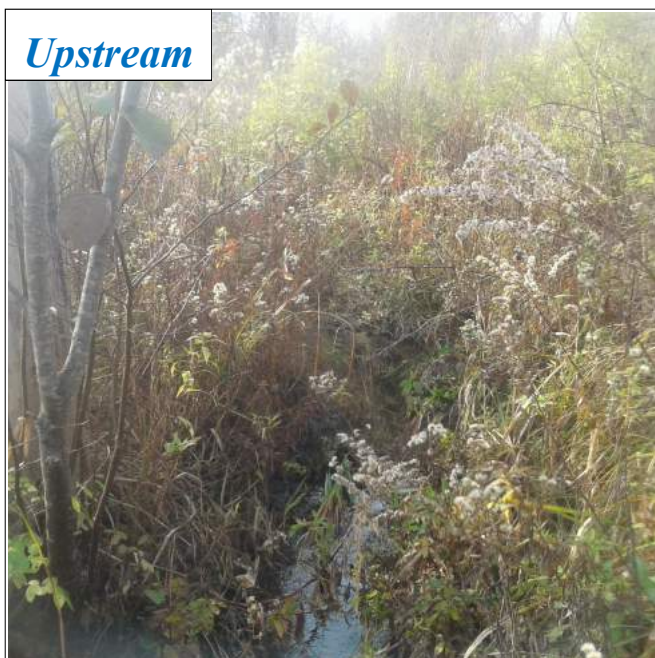
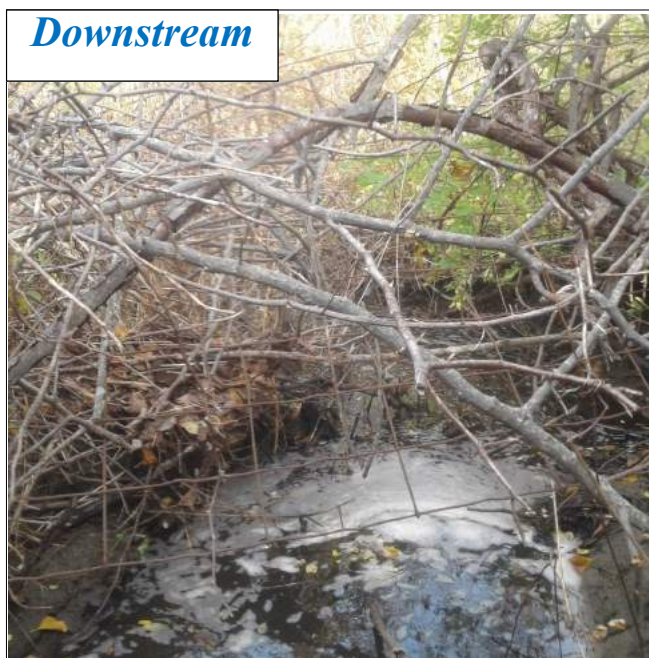
Crossing Comments: Stormwater outfall just upstream of inlet river right.

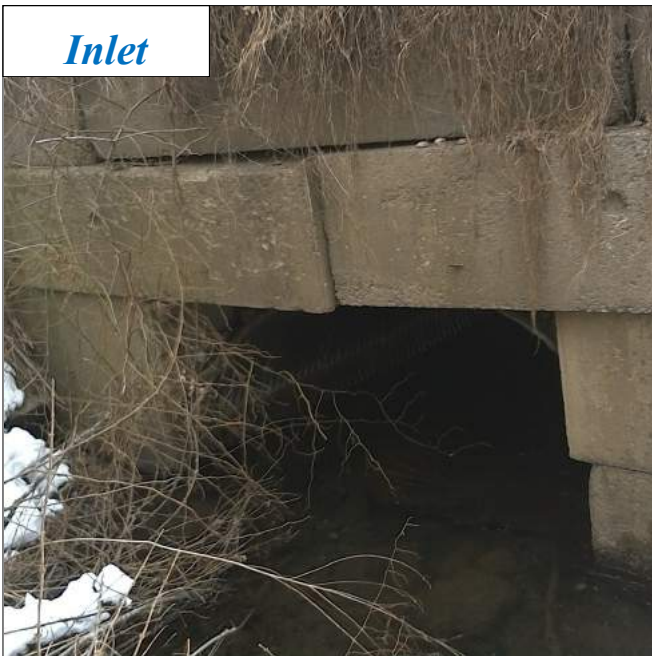
Inlet Shape/Type: Pipe Arch/Elliptical Culvert
 Inlet Drop/Grade: Perched
 Dimensions:

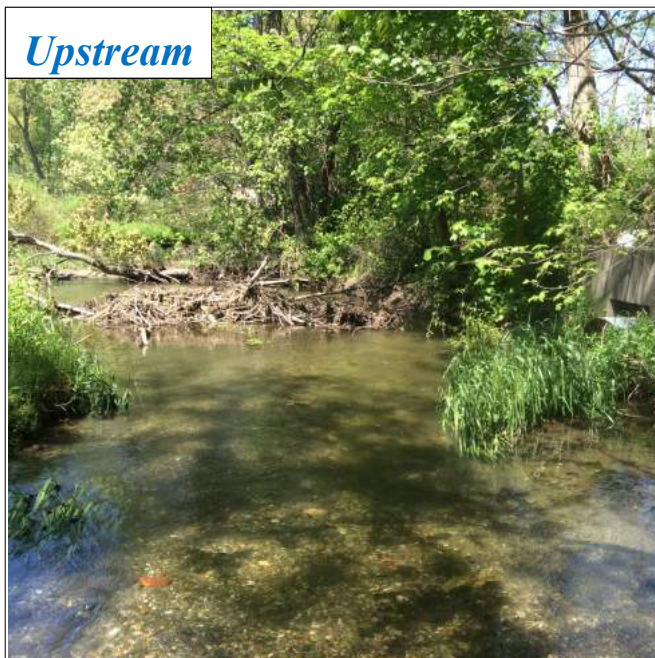
Crossing Comments: Possible illegal connection downstream river left. See downstream photo. Breached beaver dam upstream.

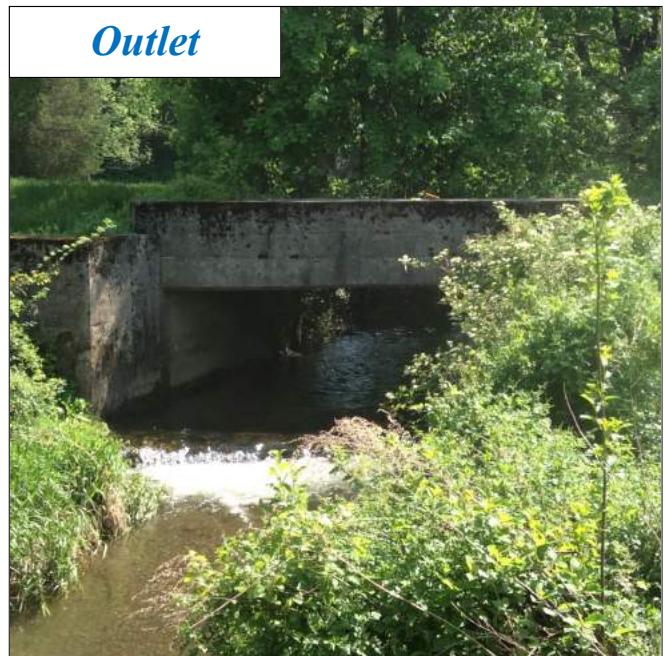
Outlet

Structure Comments: Armor creates free fall

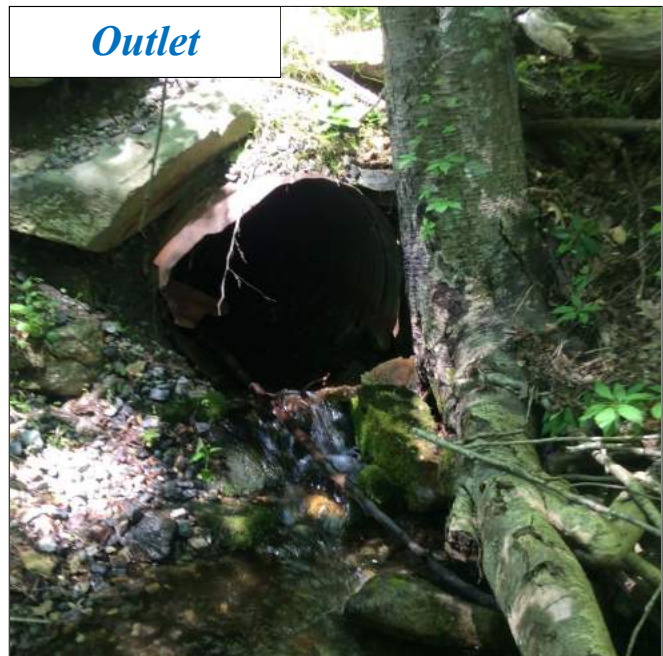
Outlet Shape: Round Culvert
 Outlet Drop/Grade: Cascade
 Drop to Stream Surface/Bottom: 0.4/ 0.8
 Dimensions:

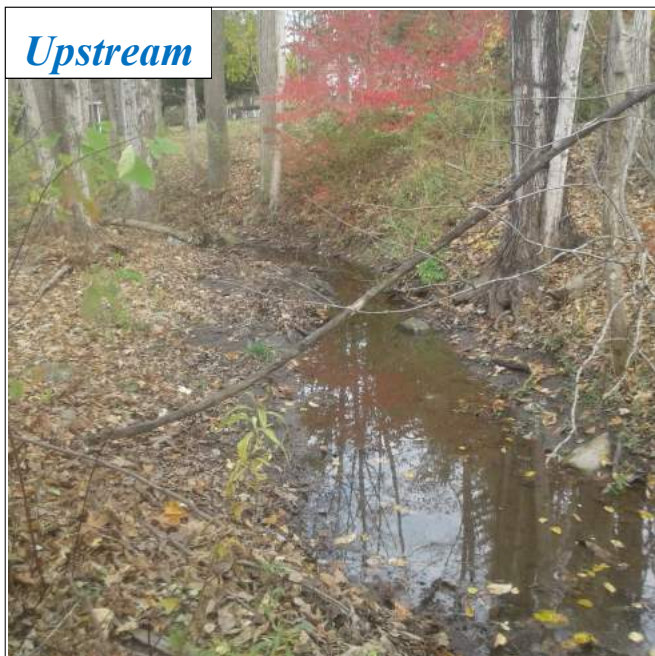
Upstream

Crossing Comments: Large tree and rock upstream of inlet with debris jam

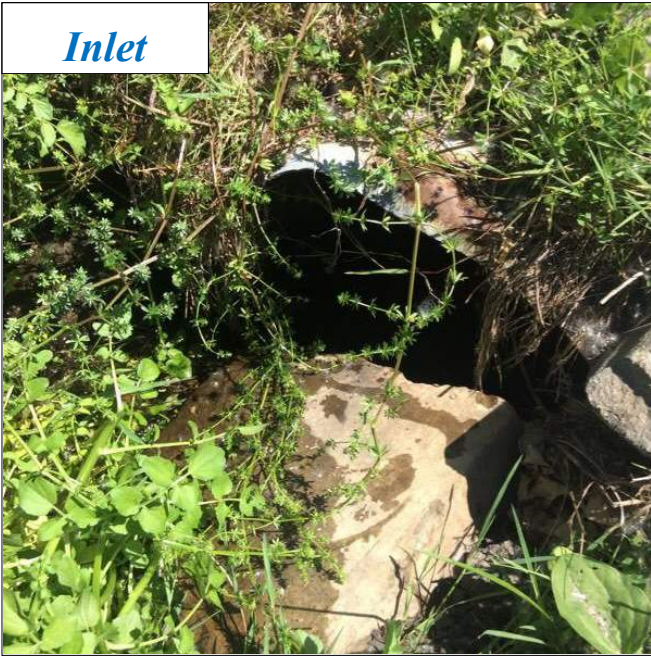
Inlet Shape/Type: Round Culvert
 Inlet Drop/Grade: Inlet Drop
 Dimensions:
 Width: 1.5, Height: 1.6
 Substrate/Water Width: 1.0
 Water Depth: 0.3
 Abutment Height: No data

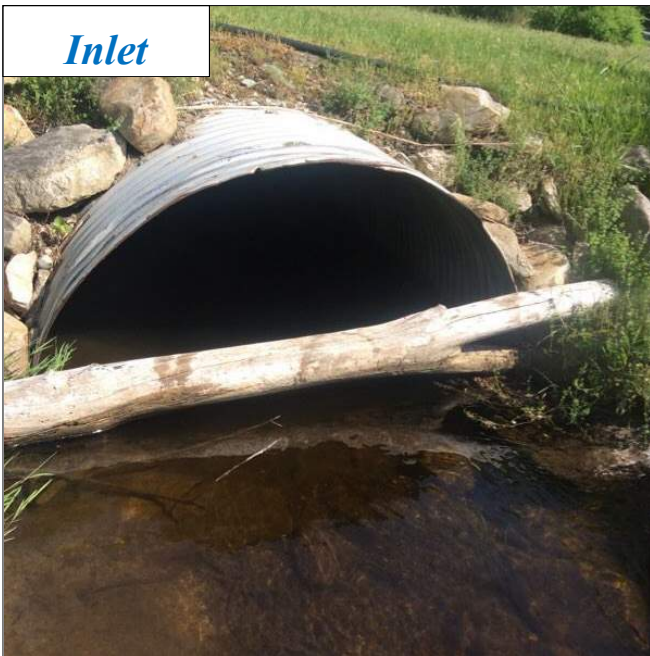
Inlet Shape/Type: Pipe Arch/Elliptical Culvert
 Inlet Drop/Grade: At Stream Grade
 Dimensions:

Width: 5.8, Height: 4.0
 Substrate/Water Width: 5.8
 Water Depth: 1.5
 Abutment Height: No data

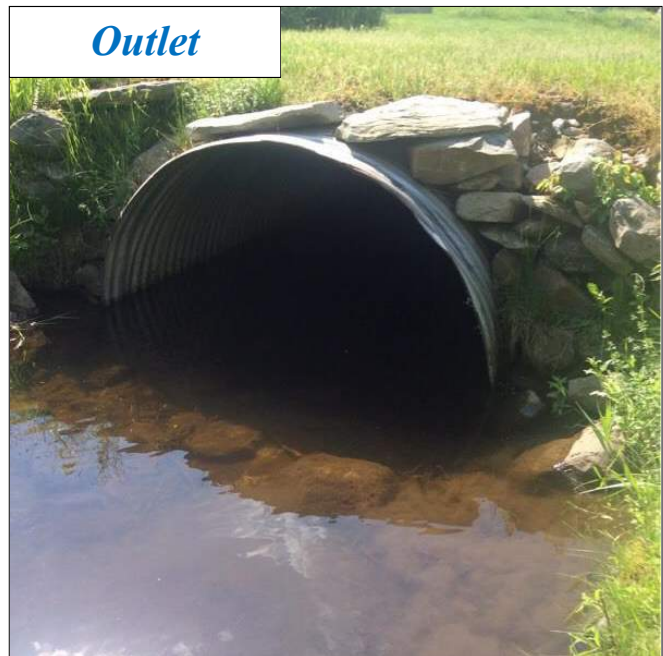
Outlet Shape: Pipe Arch/Elliptical Culvert
 Outlet Drop/Grade: At Stream Grade
 Drop to Stream Surface/Bottom: 0.0/ 0.0
 Dimensions:

Width: 5.5, Height: 4.0
 Substrate/Water Width: 5.5
 Water Depth: 1.3

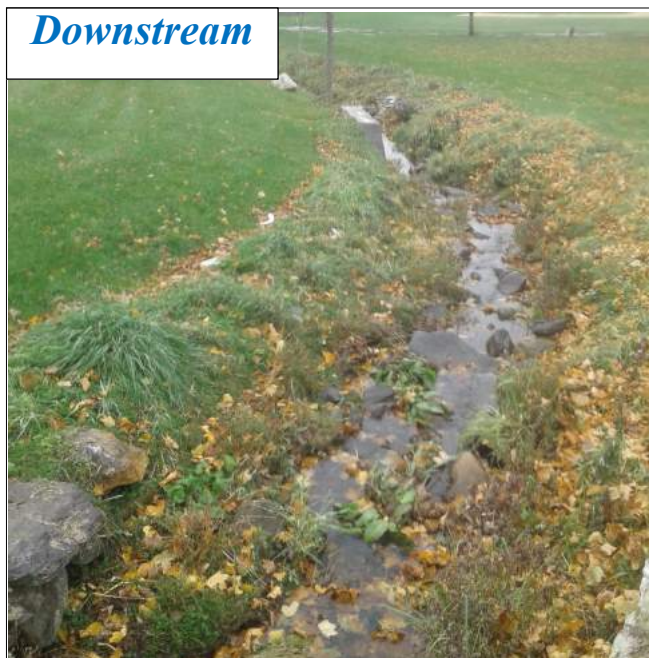
**Downstream**

**Crossing Comments:** Series (3) of large (4-5') corrugated steel pipes culverts under trails up-stream of crossing

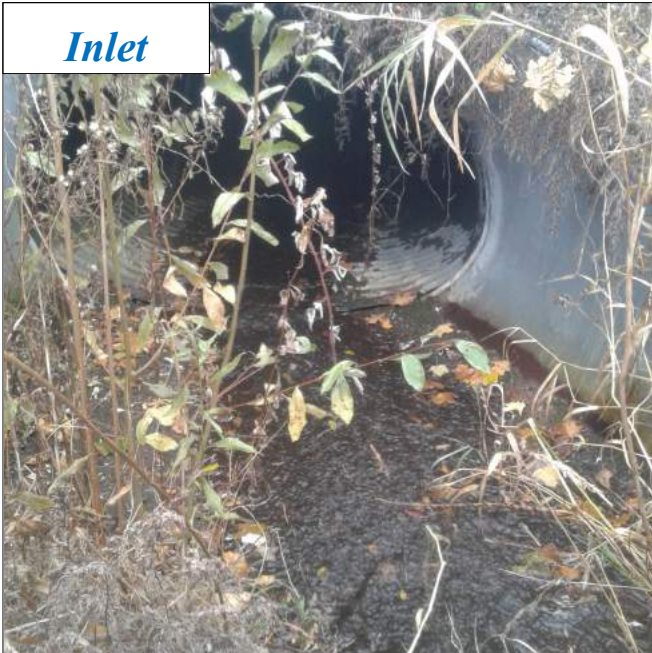
Structure Comments: Inlet is a culvert that connects to a bridge at outlet

Inlet Shape/Type: Pipe Arch/Elliptical Culvert

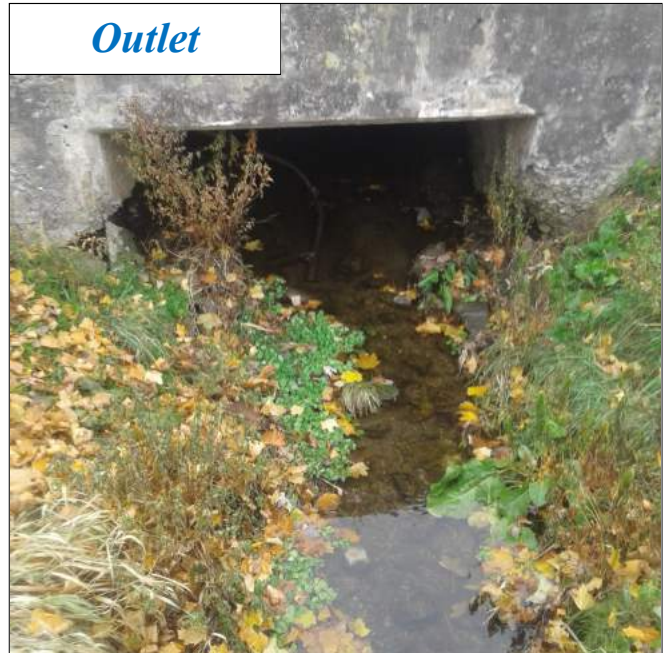
Outlet Shape: Box/Bridge with Abutments
